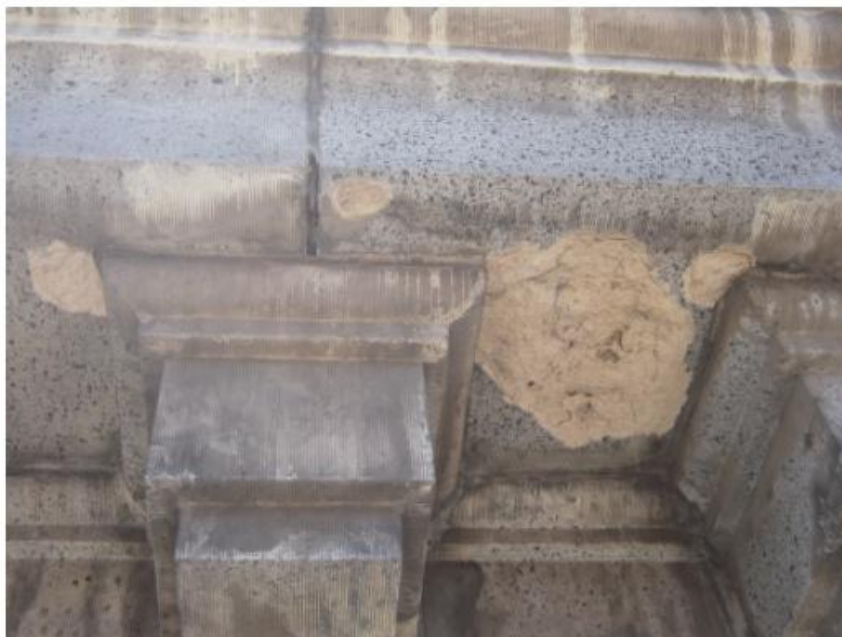
*Figure 132: Detail view of open joints, [terra cotta](#) patches, and staining at the upper cornice of the central wing of the building.*

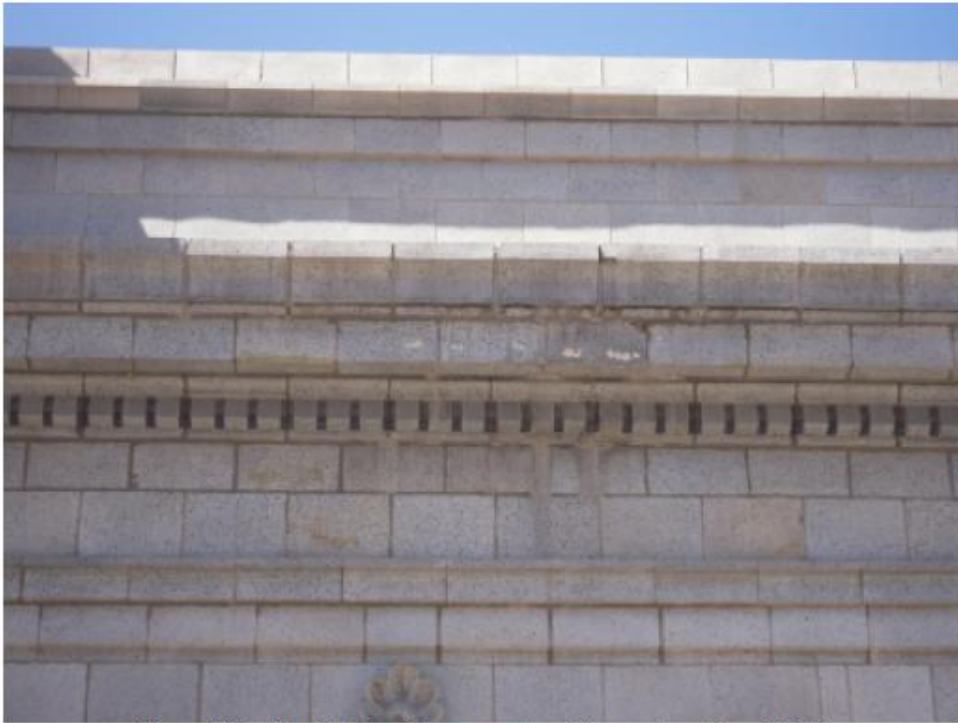
*Figure 135: Detail view of terra cotta spalling at location of drain.*

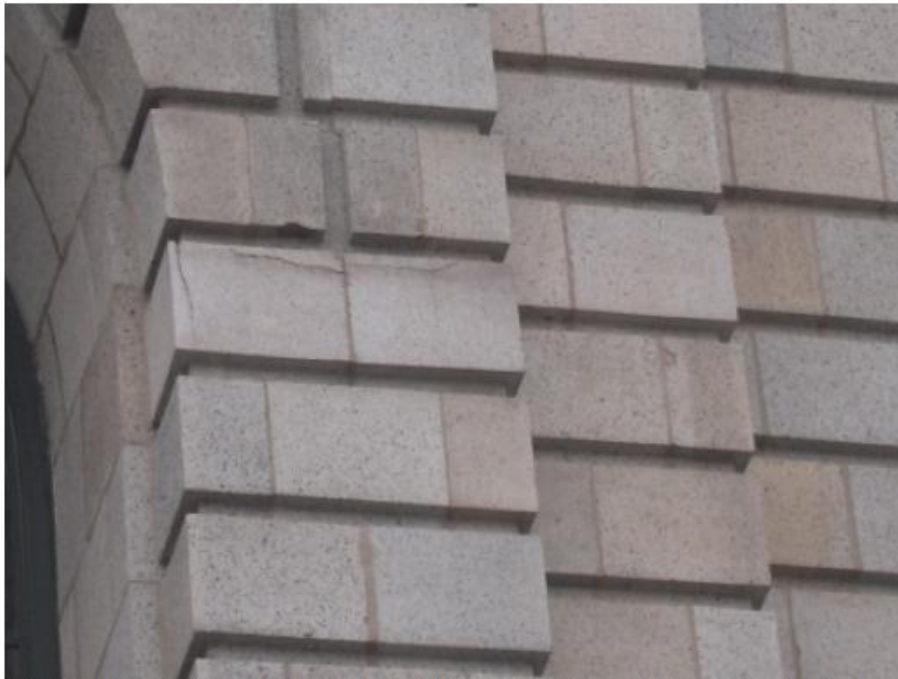
*Figure 139: Detail view of terra cotta typical of the first floor level. Note the cracked units visible in the photo. Approximately 25% of the units on the building are cracked.*

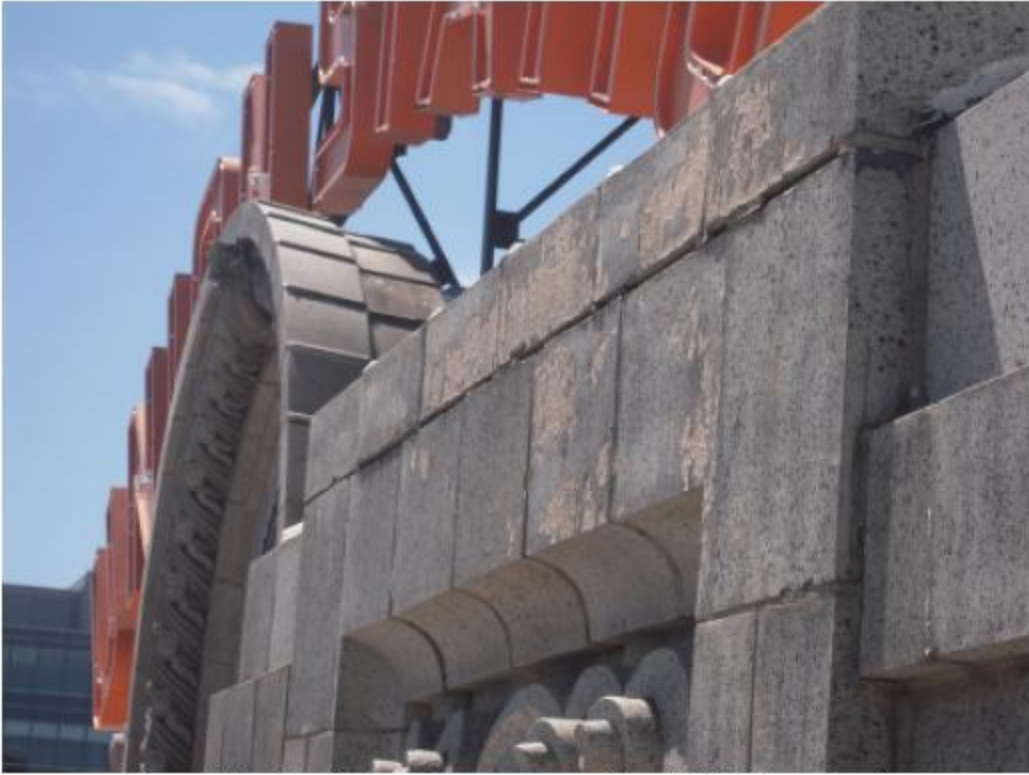
*Figure 147: Detail view of terra cotta spalling visible below the sign.*
