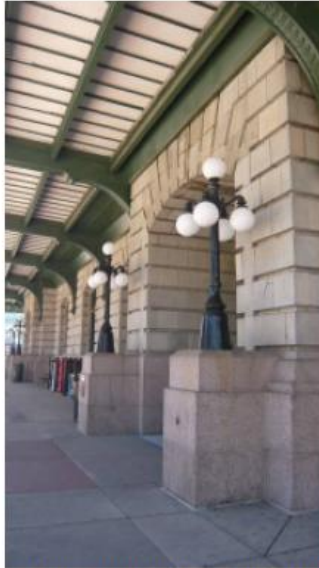
*Figure 114: Detail view of typical terra cotta at the first floor level. Note that the terra cotta is laid in coursed ashlar with deep reveals. The surrounds at the first floor window and door openings have a lower reveal to create a flat field.*
