# CIRCULATION AND USE PLAN FOR DENVER'S CITY PARK

RESTORATION IMPROVEMENTS  
ASSESSMENT AND RECOMMENDATIONS

September 2010

PREPARED FOR DENVER PARKS AND RECREATION

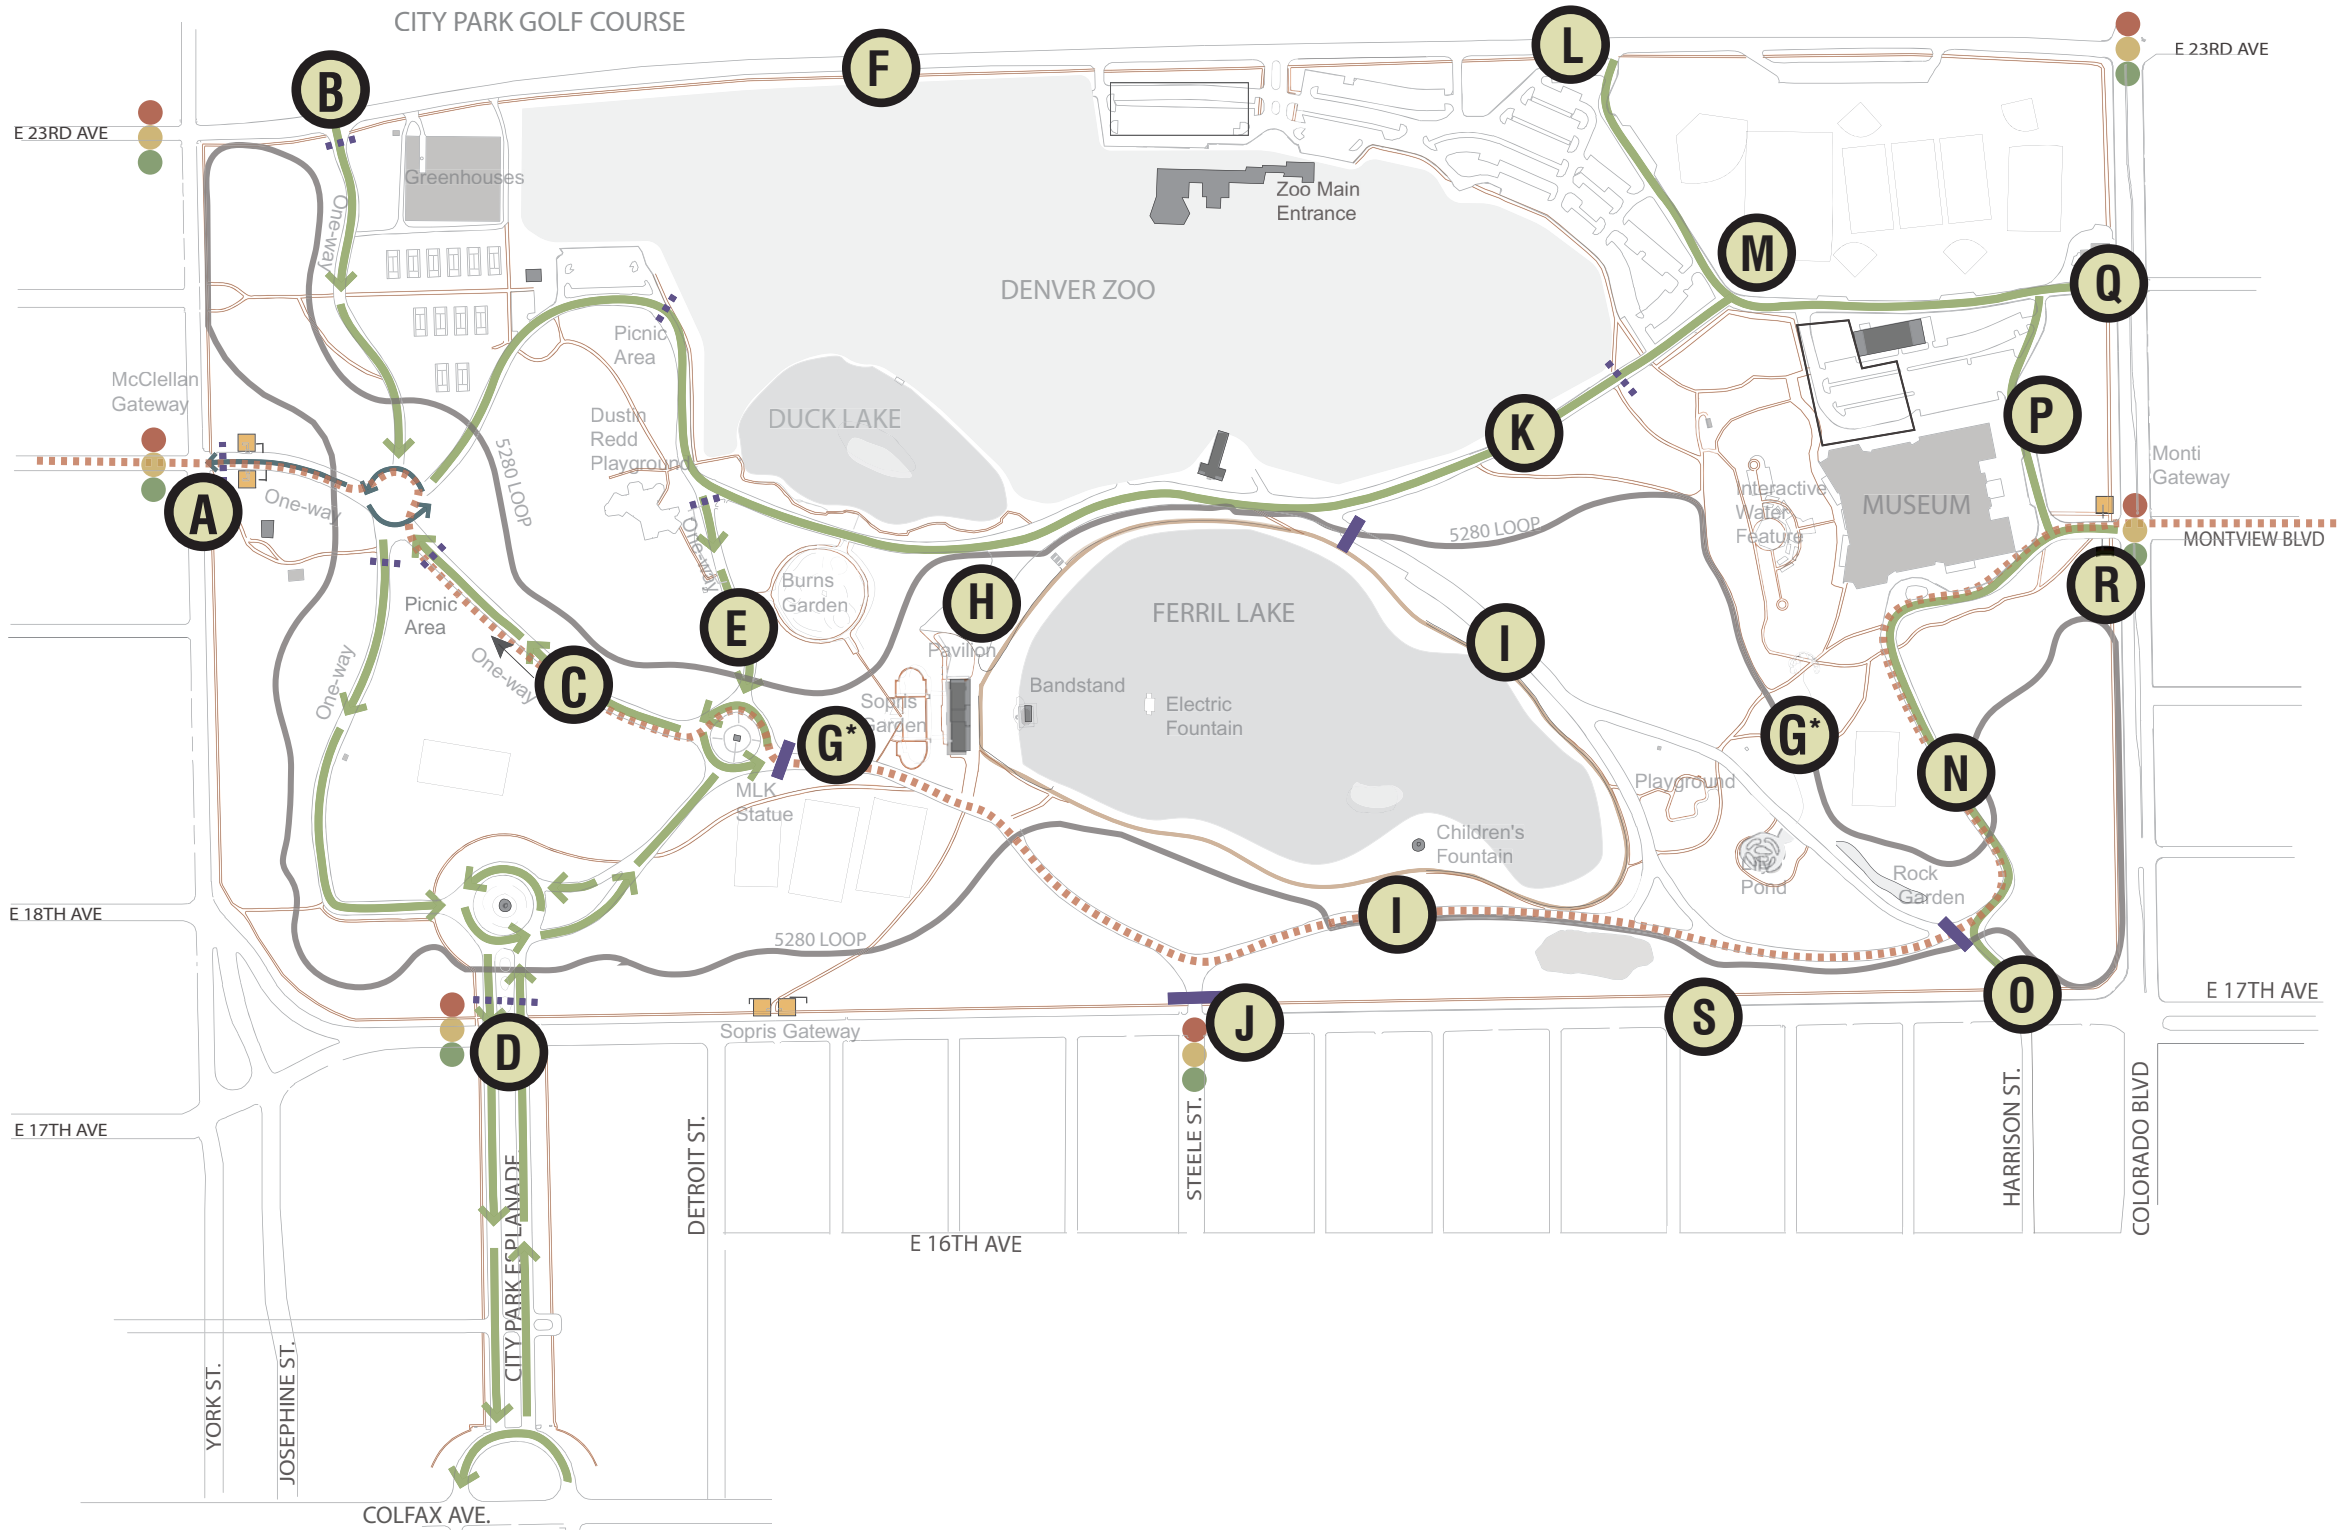
## EXISTING CONDITIONS - ISSUES AND OPPORTUNITIES

This section maps information gathered through field observations, intercept surveys, public and stakeholder meetings. The “Existing Conditions” map on the following pages shows the layout of the circulation system found in the summer of 2009. Specific areas on the “Existing Conditions” map where issues have been identified, and opportunities exist for improvement, have been given a letter which refers to a more detailed descriptions in the pages following the “Existing Conditions” map. The key issues uncovered by this study are:

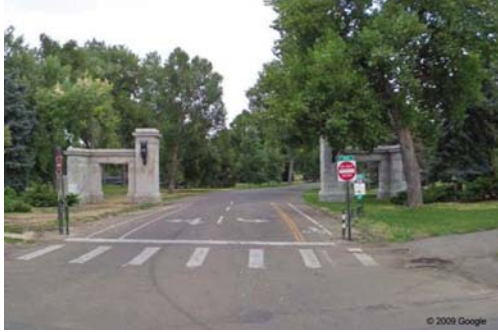
A

THE HISTORIC MCCLELLAN GATEWAY AT 21st AVE. AND YORK ST. IS CURRENTLY DESIGNED AS AN EXIT ONLY.

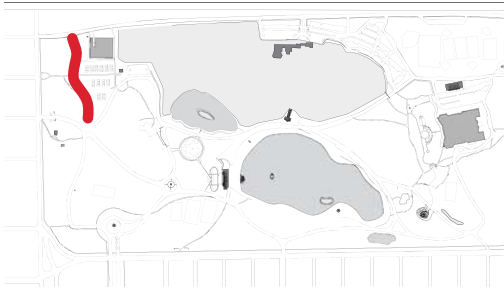
B

THE ENTRY ALONG 23RD AVE. IS HEAVILY USED, BUT DIFFICULT TO FIND.

- Entry and direction signage would be appropriate at this entrance due to the amount of traffic that currently enters here and the expected increased in traffic as the greenhouse comes into public use.

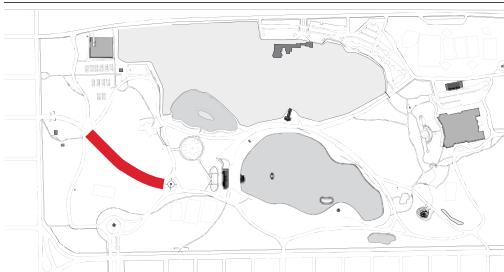
C

THE ROAD BETWEEN THE WEST MEADOW AREA IS PERCEIVED TO BE A BARRIER FOR PEDESTRIANS AND CUTS THE MEADOW IN HALF.

- This area presents an opportunity for increased access and flexible use for a variety of activities and pedestrian modes of travel by closing the road to vehicular traffic. (also refer to letter E)

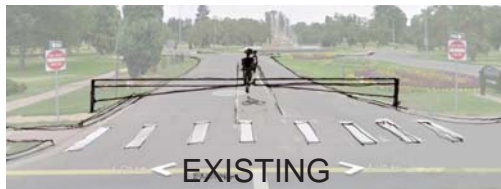
D

THE ESPLANADE ENTRY FROM 17TH AVE. IS A MONUMENTED ENTRANCE WHERE BICYCLE ACCESS IS HINDERED WHEN GATES ARE CLOSED.

- Gates could be redesigned to allow for cyclists to pass when closed.

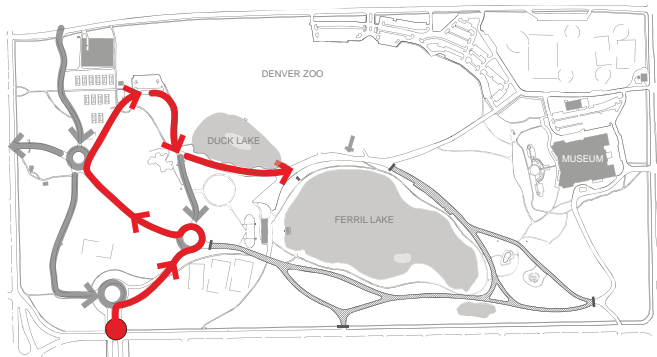
E

THE LAYOUT AND SEQUENCE OF ONE-WAY ROADS ARE CONFUSING MAKING IT DIFFICULT TO NAVIGATE THROUGH THE PARK.

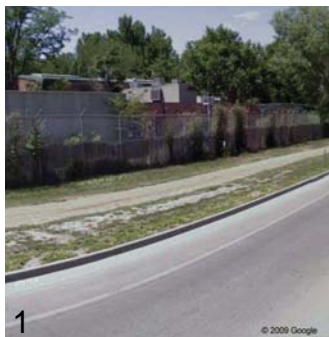
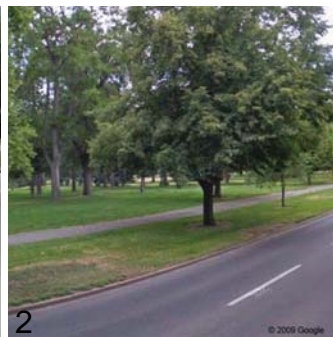
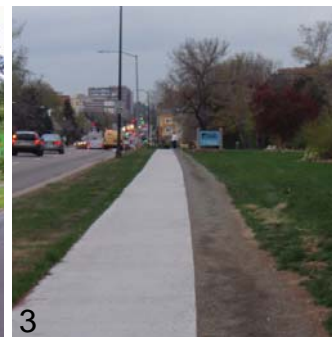
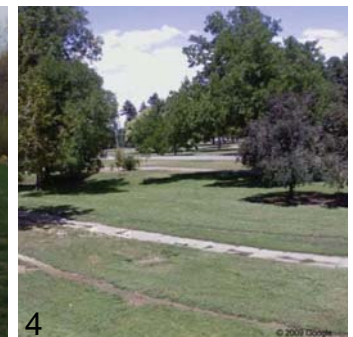
F

INCONSISTENT MATERIAL TYPES AND WIDTHS OF THE PERIMETER PATH HAVE VARYING USER AND MAINTENANCE QUALITIES. MANY VISITORS EXPRESS THE DESIRE FOR A CONSISTENT LOOP AROUND THE PERIMETER OF THE PARK.

- 1. The 8' crusher fines path along the north edge of the park is appealing and gets moderate use in dryer seasons, but gets muddy easily and cannot be plowed in snowy conditions.

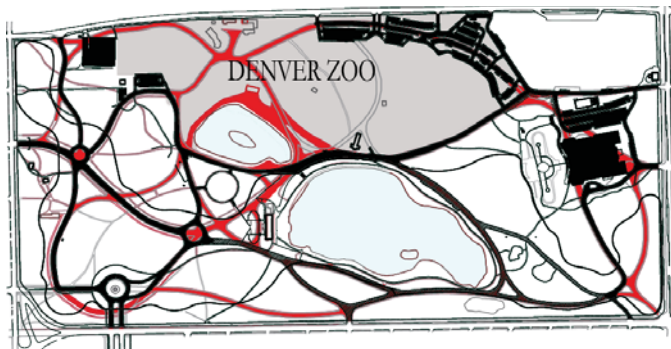
G\*

PATHWAY HIERARCHY AND SINOUS CONNECTIONS HAVE DIMINISHED OVER TIME.

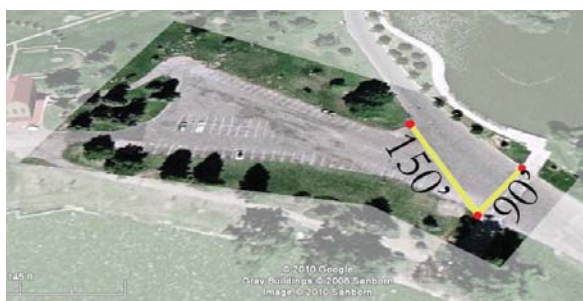
H

THE PAVILION PARKING LOT IS INEFFICIENT AND UNDESIRABLE FOR PEDESTRIAN MOVEMENT.

- The pavilion parking lot is situated on leftover paving from a removed historic roadway making it inefficient in its layout. The entry is vast and potentially unsafe making it undesirable for pedestrian movement.

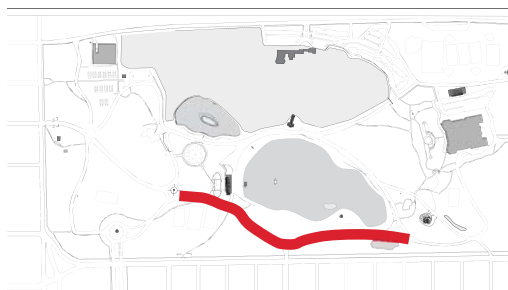
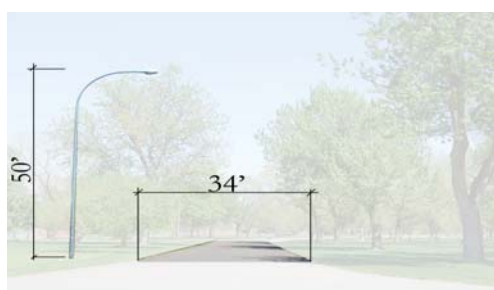
I

THE CLOSED ROADWAY CURRENTLY USED AS PEDESTRIAN PROMENADE FEELS LIKE A ROAD.

- *Bollards could be used to improve the character of the pedestrian promenade.*

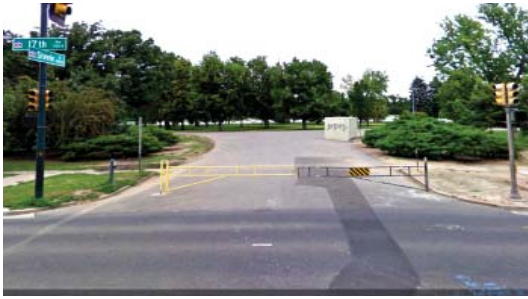
J

*CLOSED GATES, USED TO PREVENT VEHICULAR TRAFFIC, NEGATIVELY AFFECT THE CHARACTER OF THE PEDESTRIAN PROMENADE*

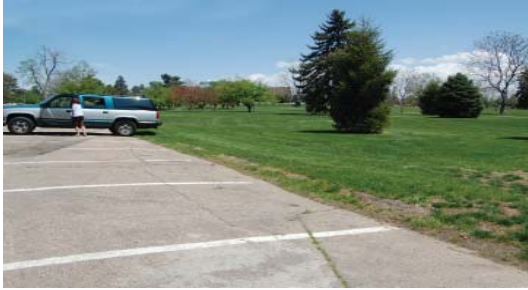
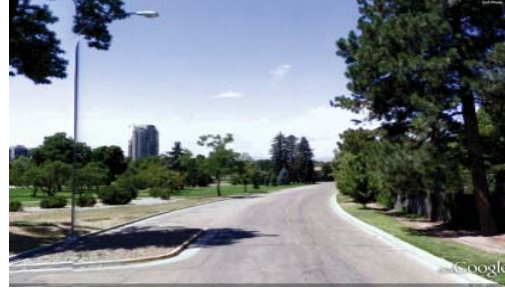
K

*MAIN PARK ROAD CHARACTER IS MORE CONSISTENT WITH A VEHICULAR SERVICE ROAD RATHER THAN A PARK BOULEVARD.*

- *The road could be realigned and given entry monumentation to signify its use as a major Park entrance.*

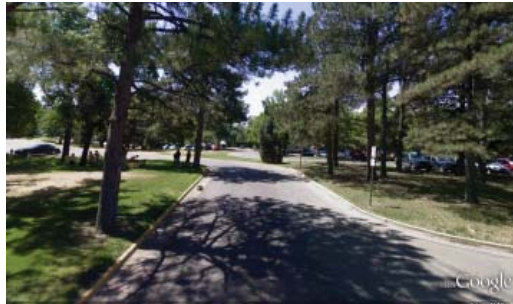
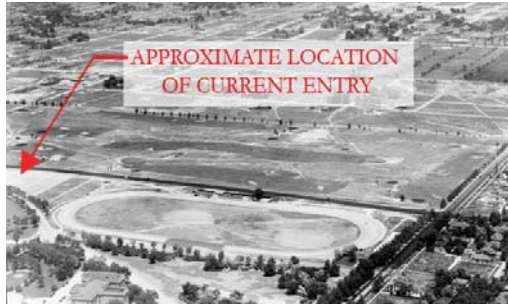
L

*THE PARK ENTRANCE ROAD AT 23RD AVE. IS NOT AN OBVIOUS ENTRANCE INTO THE PARK.*

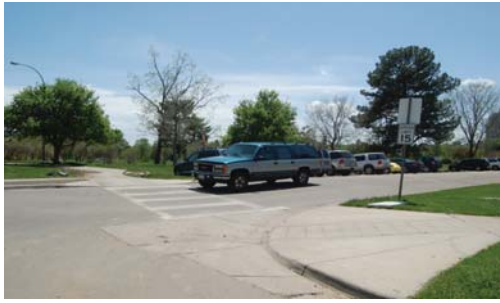
M

THE DESIGN OF THE INTERSECTION AT THE MUSEUM, ZOO & PARK ENTRY ROADS IS CONFUSING AND DOES NOT DIRECT TRAFFIC INTO THE PARK.

- The intersection could be reconfigured and signage added to direct visitors into the Park.

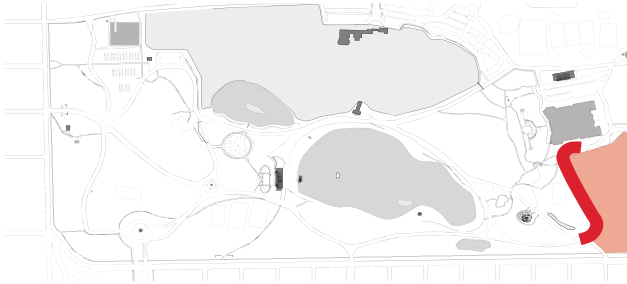
N

PREVIOUS STUDIES, AND THE MOST RECENT MASTER PLAN, SUGGEST RESTORATION OF THE HISTORIC PARK ROAD ALIGNMENT IN THE EAST MEADOW.

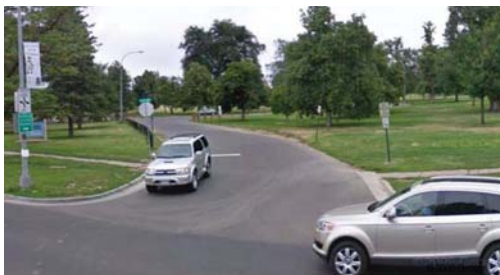
O

THE 17TH AVE ENTRANCE (AT HARRISON ST.) ENABLES CUT THROUGH TRAFFIC FROM MONTVIEW AND COLORADO BLVD. AND IS UN-NECESSARY FOR PARK ACCESS.

- This road could be realigned so that it doesn’t pass through the museum parking lot, reducing traffic jams caused by people trying to find museum parking.
- The historic roundabout at the Monti Gateway entrance could be reconstructed with signs to provide character and directional assistance to visitors entering through the gateway.

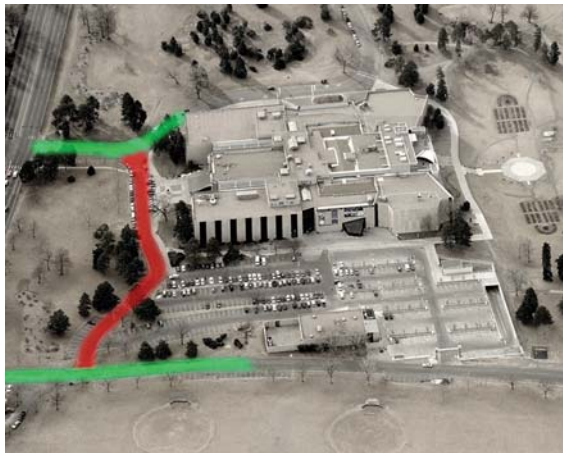
P

THE ROAD ON THE EAST SIDE OF THE MUSEUM (IN RED) IS PERCEIVED TO ONLY SERVE MUSEUM PARKING, RATHER THAN AS A CONNECTION TO THE LARGER PARK ROAD SYSTEM (IN GREEN).

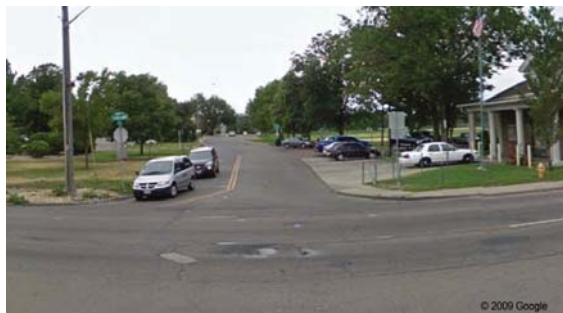
Q

THE CHARACTER OF THE ENTRY FROM COLORADO BLVD. AT 22ND AVE. IS NOT CONSISTENT WITH OTHER GATEWAY ENTRY POINTS.

- Future improvements at other entrances will make this a minor entry, however, park signage should be provided.

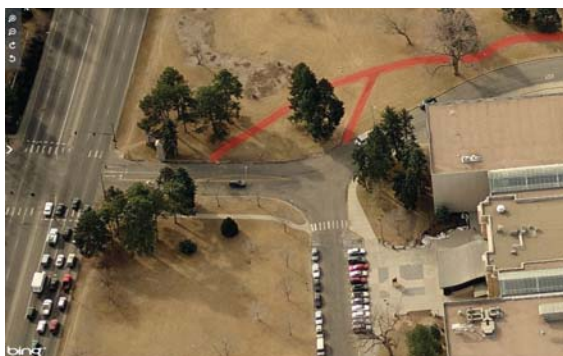
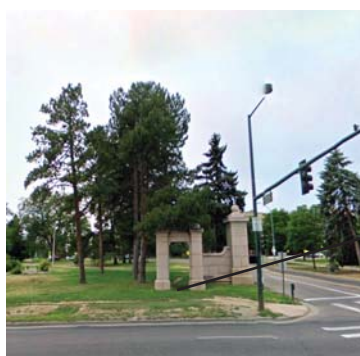
R

Missing pedestrian connection

PATHWAYS DEAD END OR NO LONGER MAKE SINUOUS CONNECTIONS AT THIS MONUMENTED ENTRANCE

- Paths should be realigned to pass through the “pedestrian gateways” to reestablish those connections and improve the “Gateway” character.

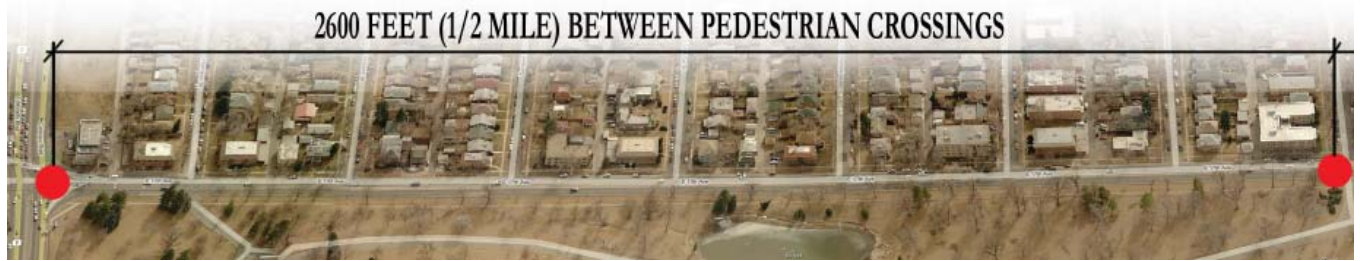
*A LACK OF PEDESTRIAN CROSSINGS ON 17TH AVE. BETWEEN COLORADO BLVD AND STEELE ST. MAKE ACCESS FOR PEDESTRIANS DIFFICULT.*

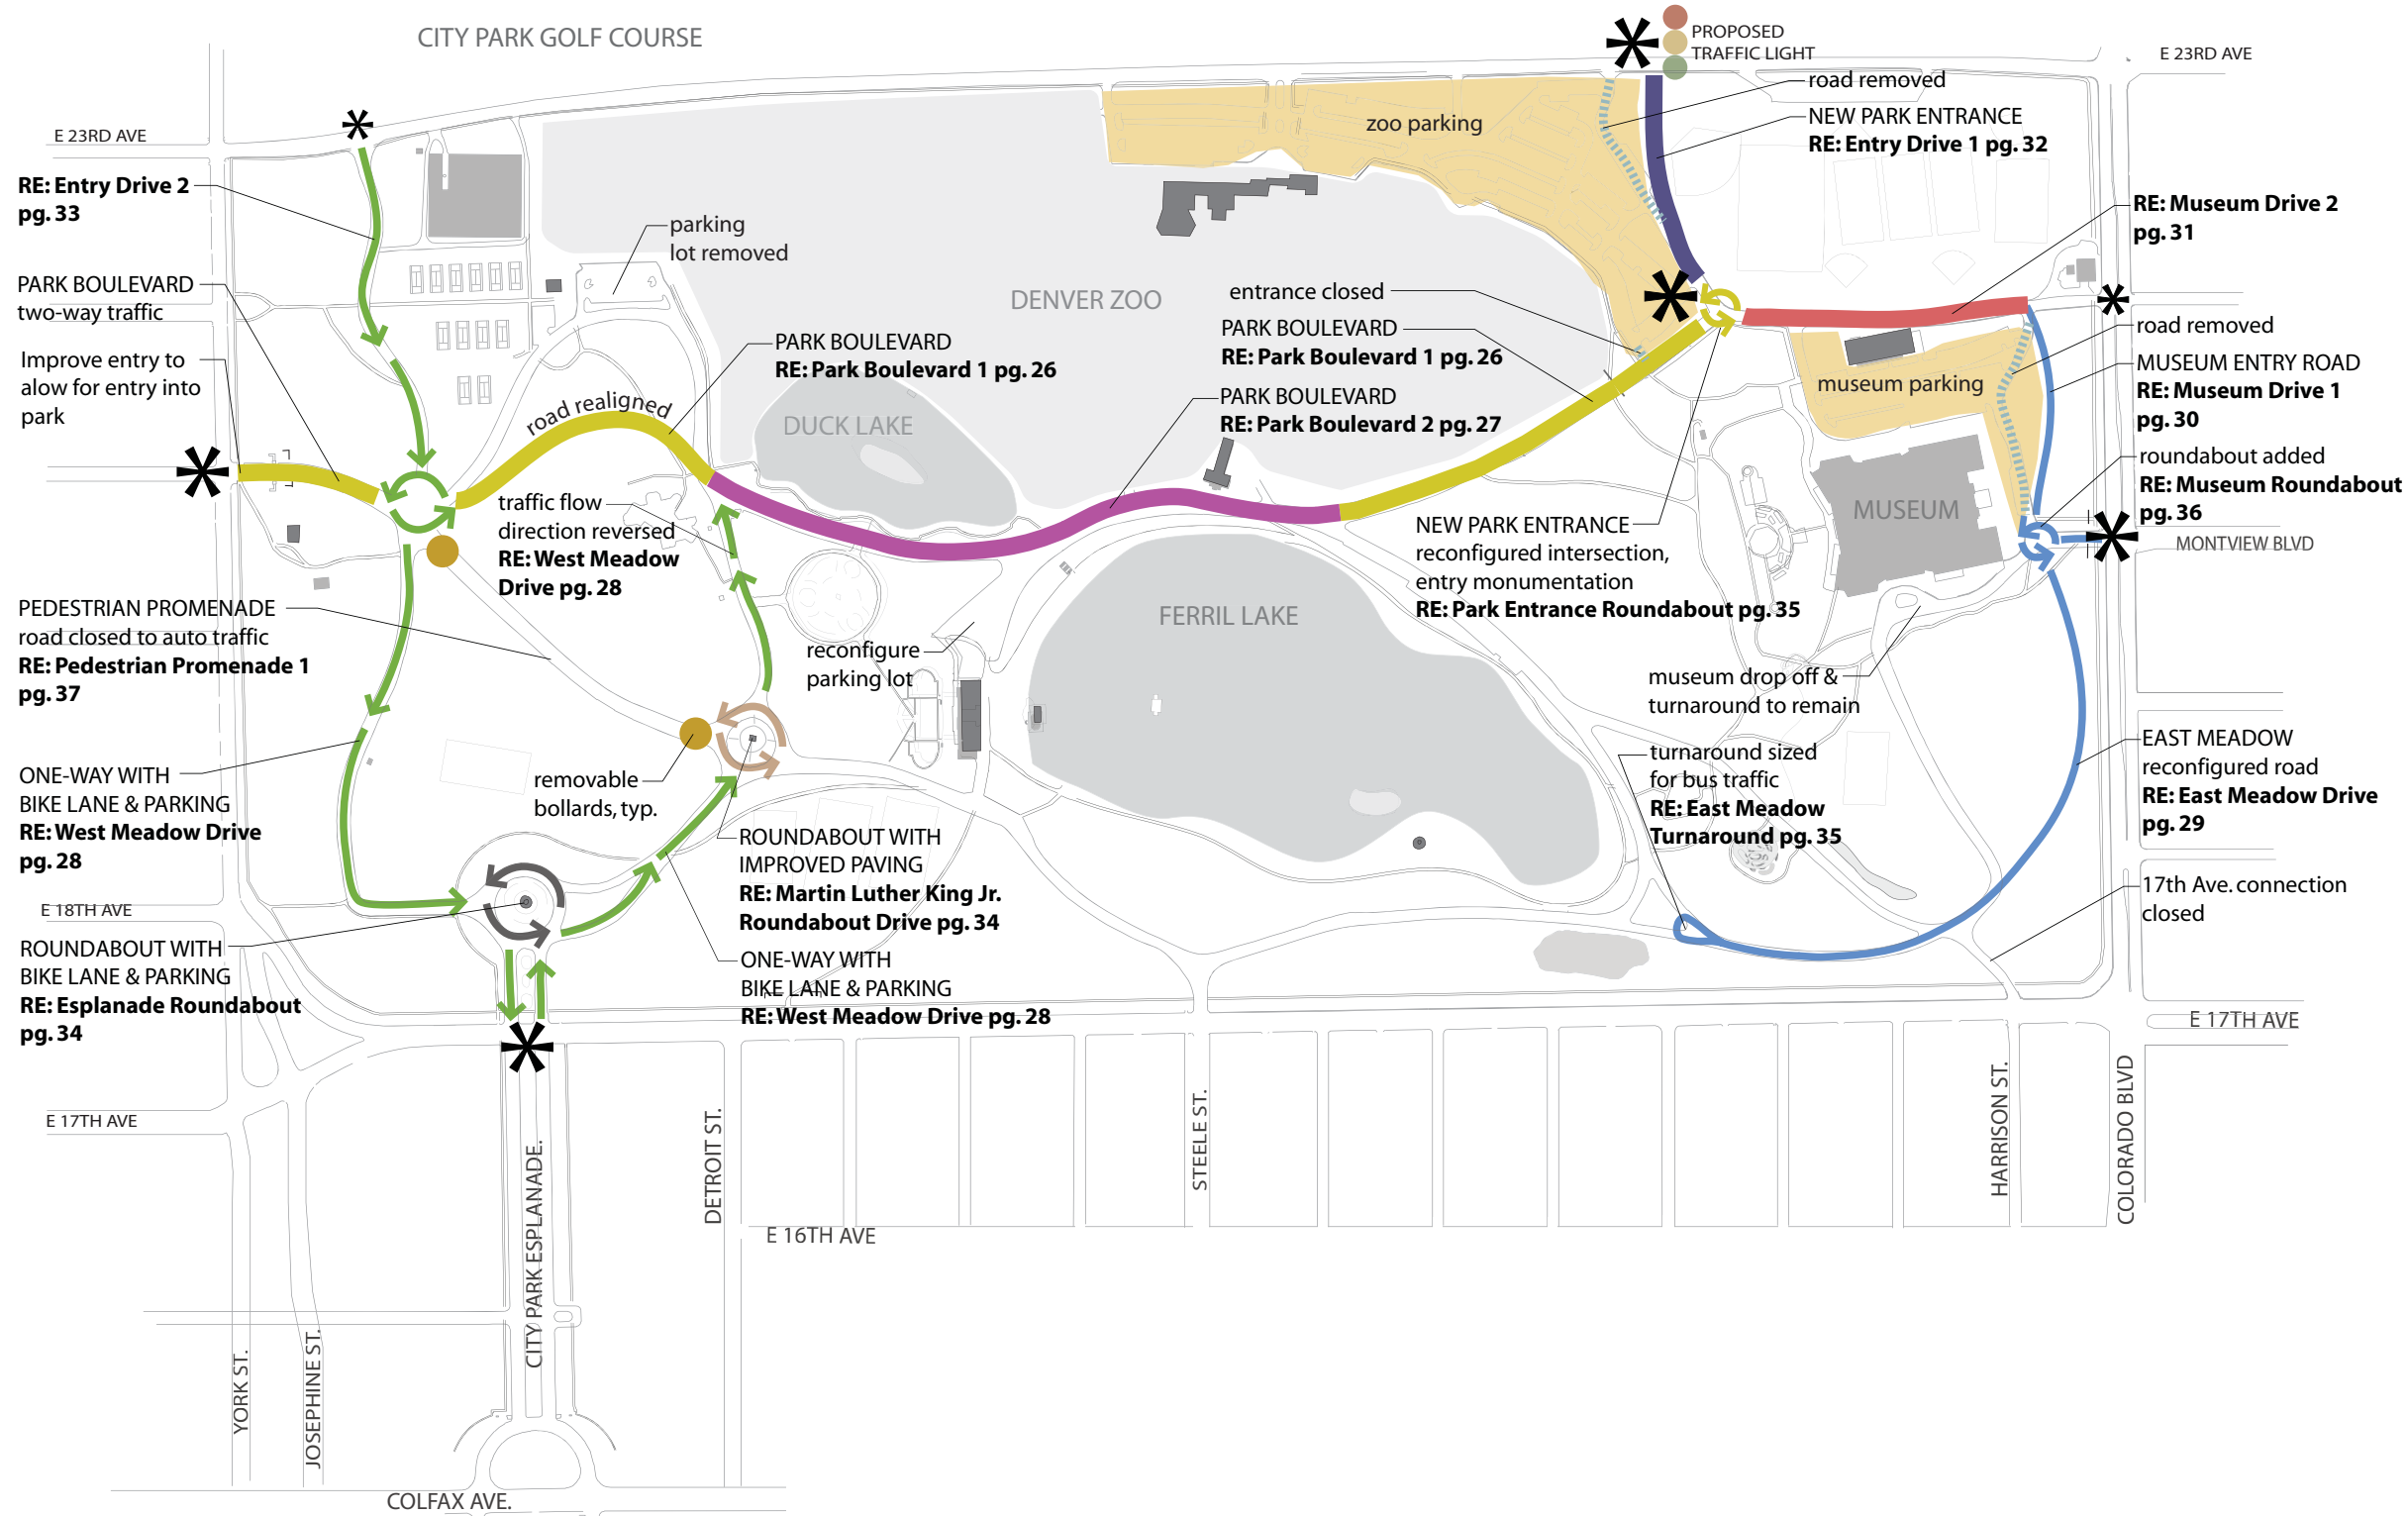
- Vehicular Route
- Parallel Parking
- Head-In Parking
- 45 Degree Angled Parking
- 35 Passenger Car Parking Spaces

Estimated Roadway Parking Spaces (Summer 2009): 750  
Proposed Plan Roadway Parking Spaces: 669

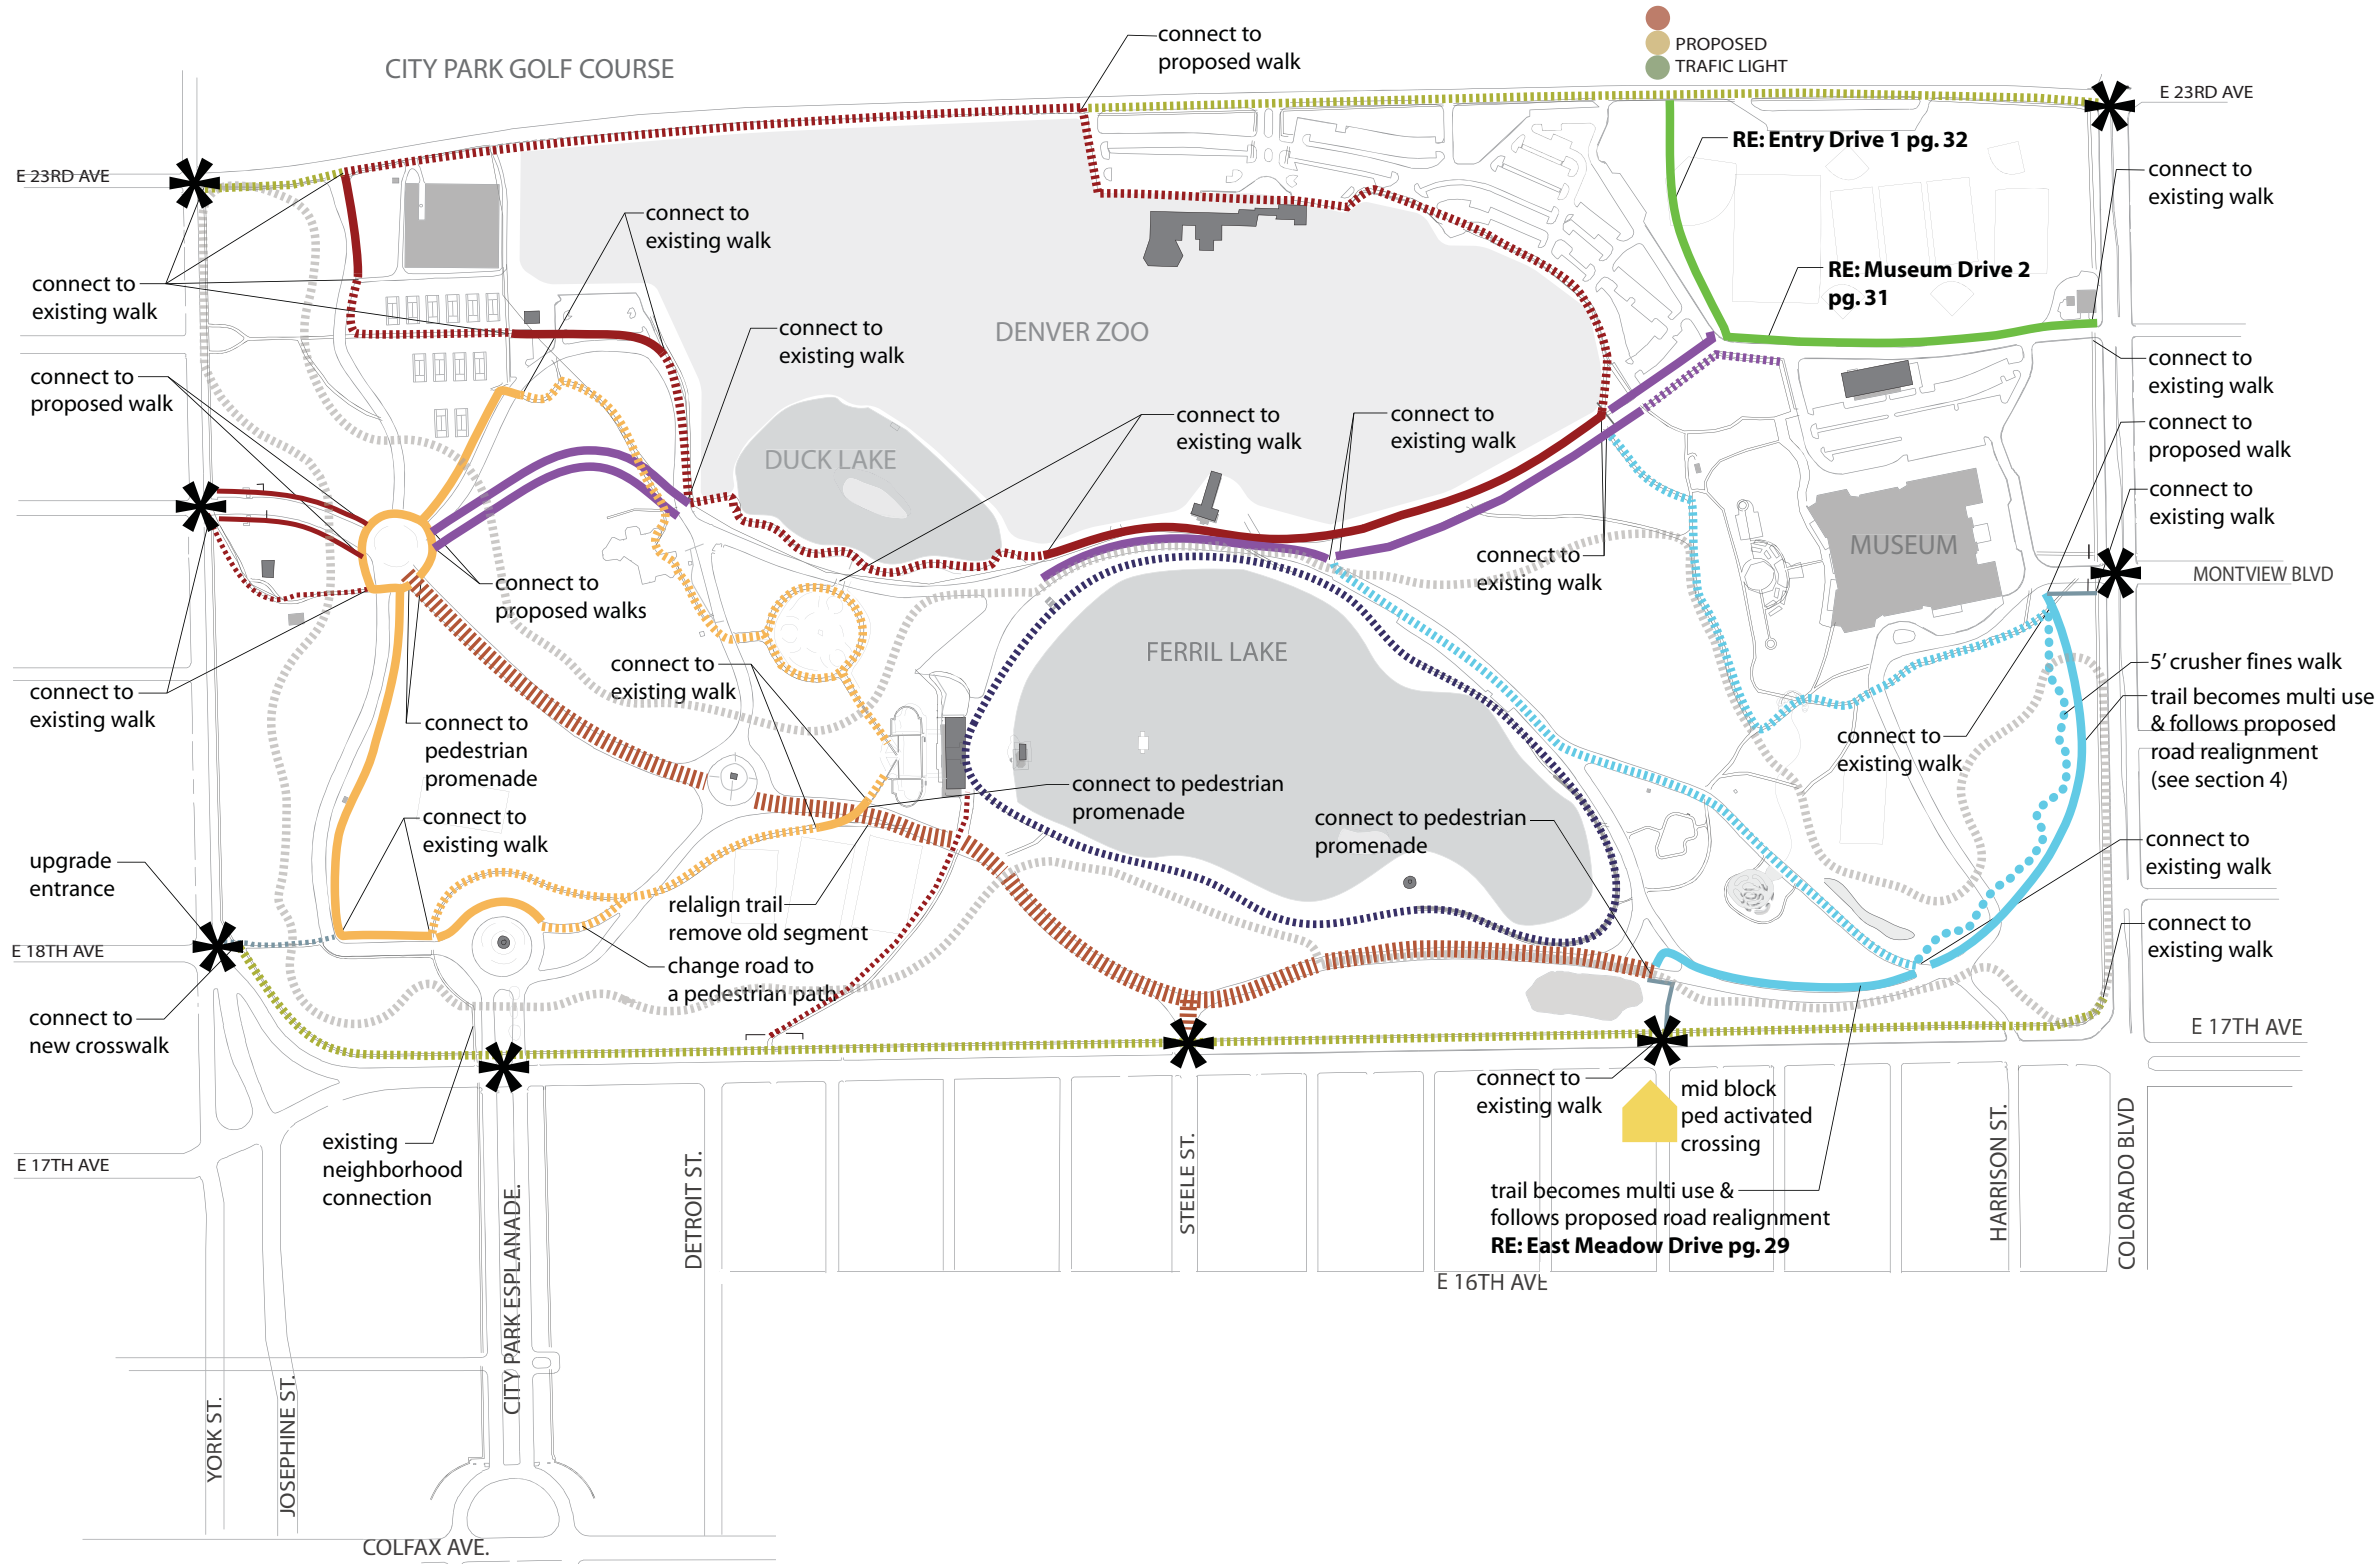
- 5280 loop (existing - no work proposed)  
**RE: 5280 Trail pg. 41**
- Ferril Lake Loop (existing - add benches & trash cans)  
**RE: Lake Loop pg. 41**
- West Meadow Garden Loop (proposed) & (existing) alterations required

- Major pedestrian entry

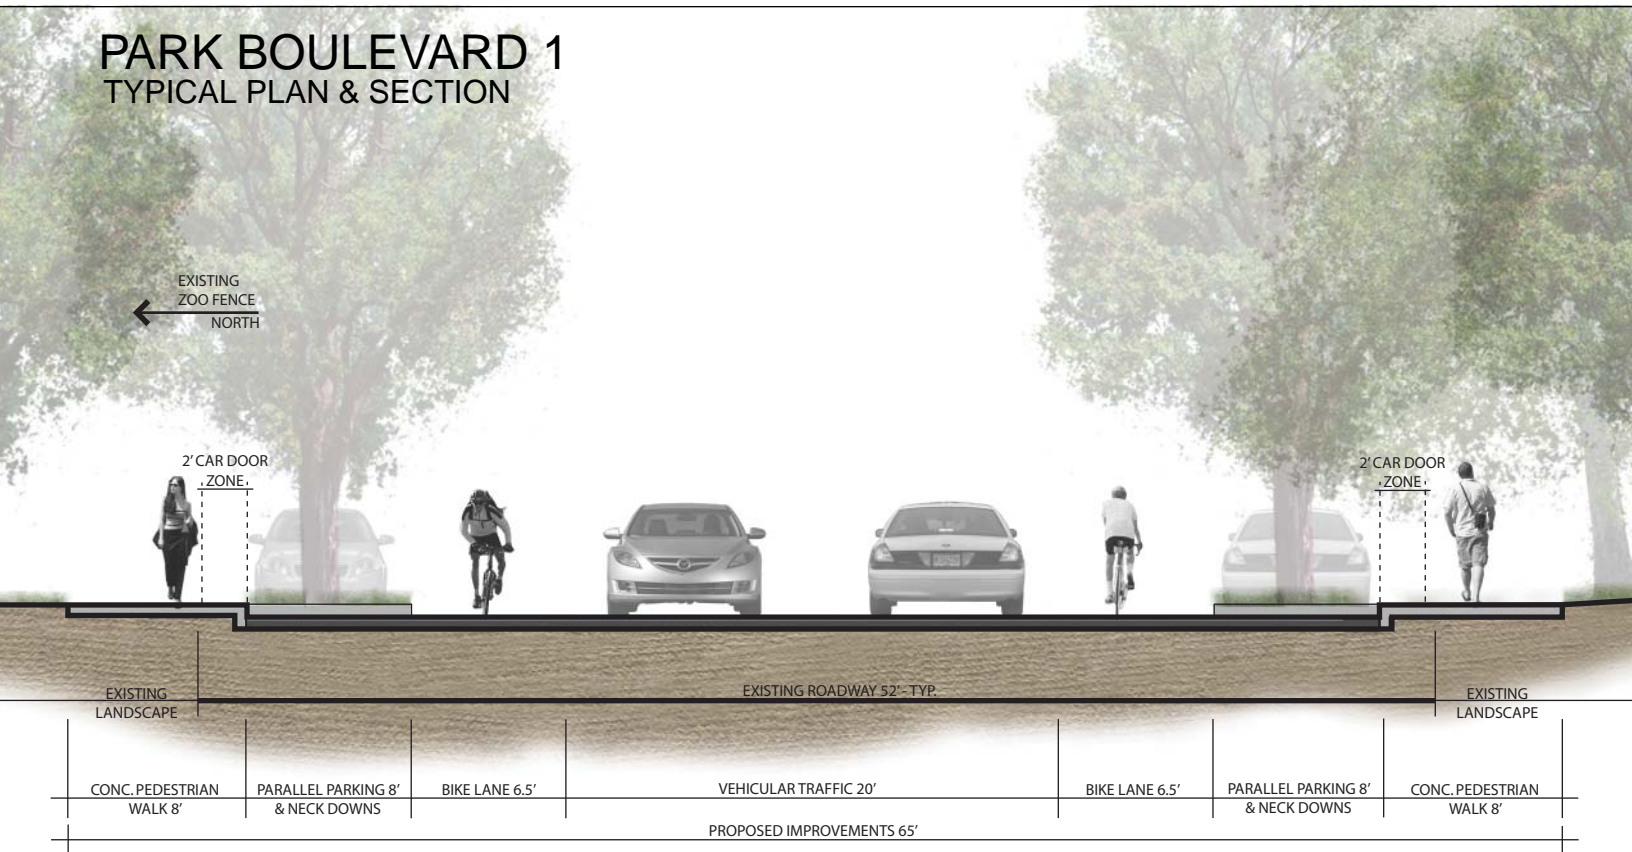
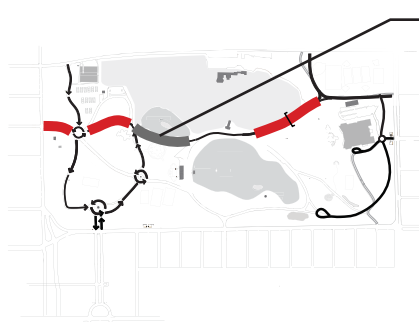
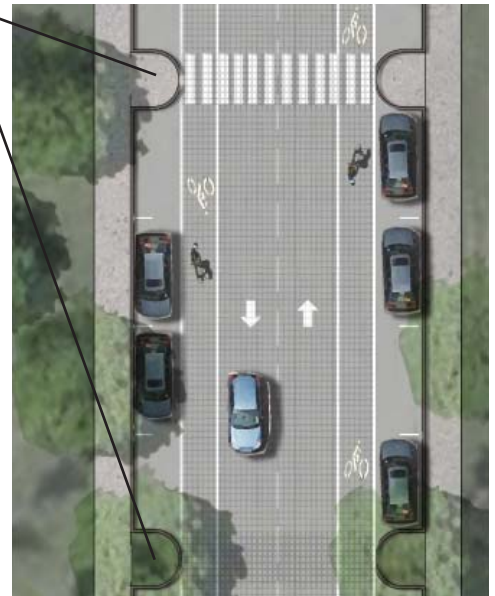
### PARK BOULEVARD 1 TYPICAL PLAN & SECTION

This section of roadway is not included in this report due to the narrowness of the road & work presently underway

- Two-way auto & bike traffic (dedicated lanes)
- Parallel parking on both sides
- 6.5' bike lanes
- 8' attached concrete walks on both sides (to allow for car doors to open & pedestrian traffic to safely pass).
- Neck downs at pedestrian crossing
- Planted neck downs
- Striping at pedestrian crossings
- Curb & gutter

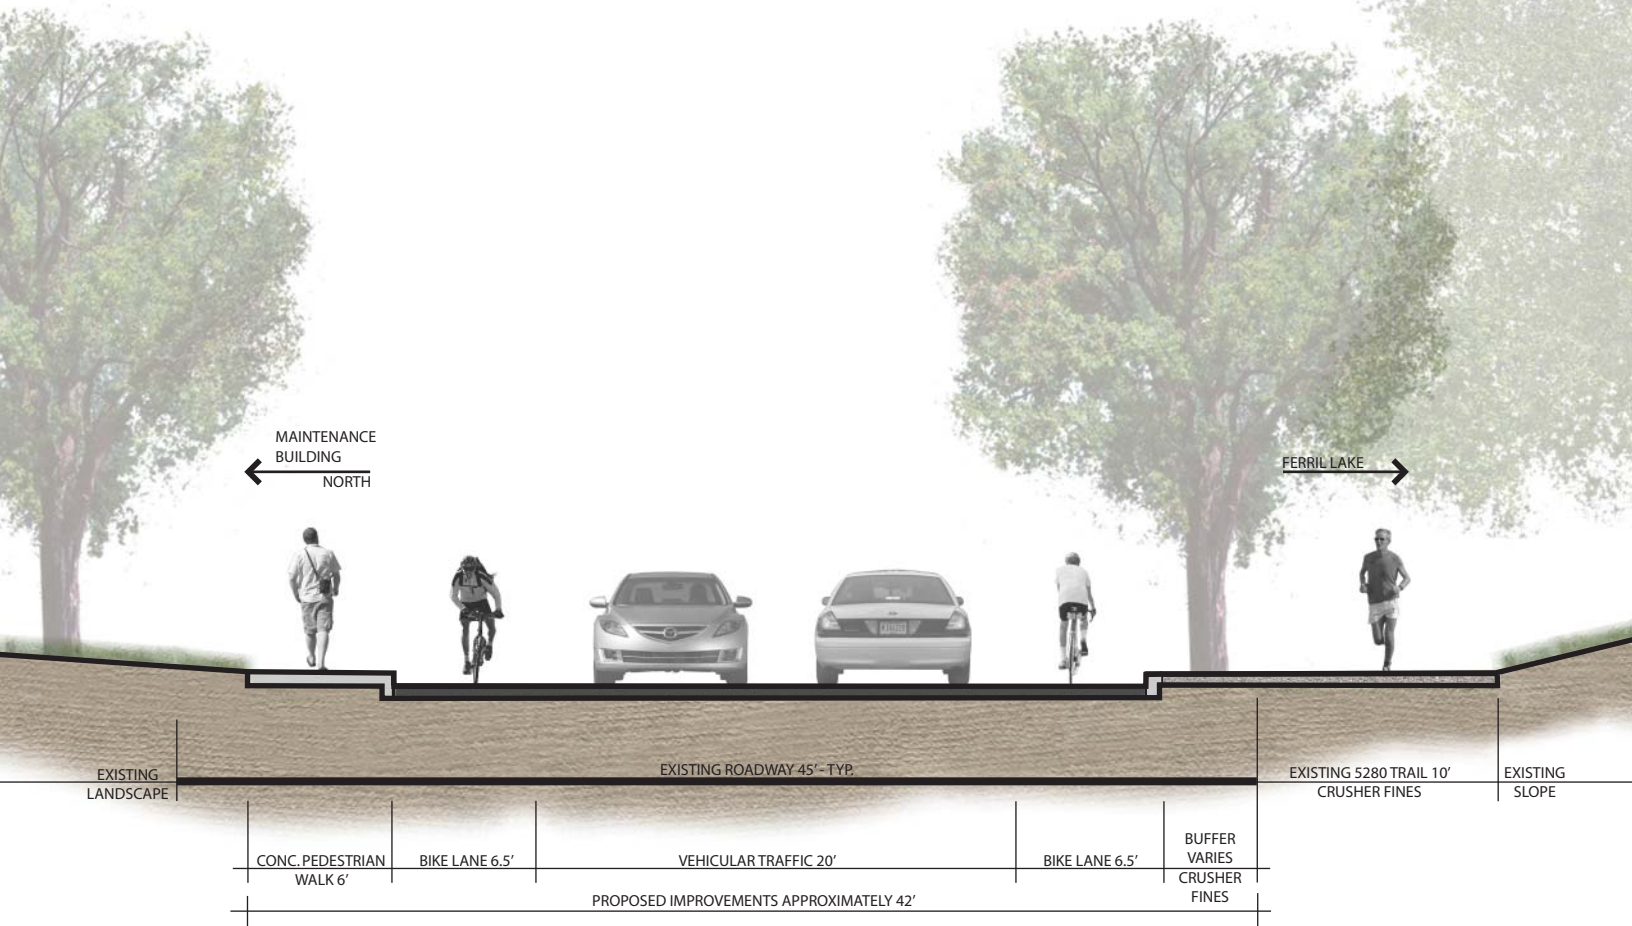
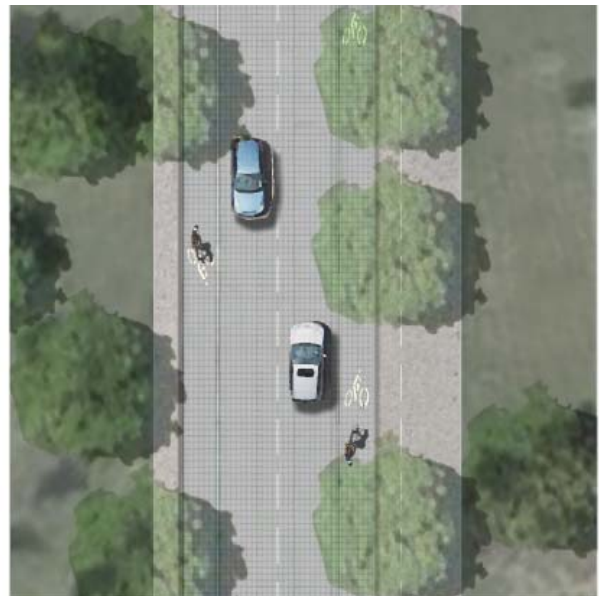
# PARK BOULEVARD 2

- Two-way auto & bike traffic (dedicated lanes)
- No parking on both sides
- 6.5' bike lanes
- 6' attached concrete walks on North side
- Extend a crusher fine buffer from the 5280 trail to the curb on the South side. Plant trees or grasses in the crusher fines buffer along the roadway.
- Striping at pedestrian crossings
- Curb & gutter

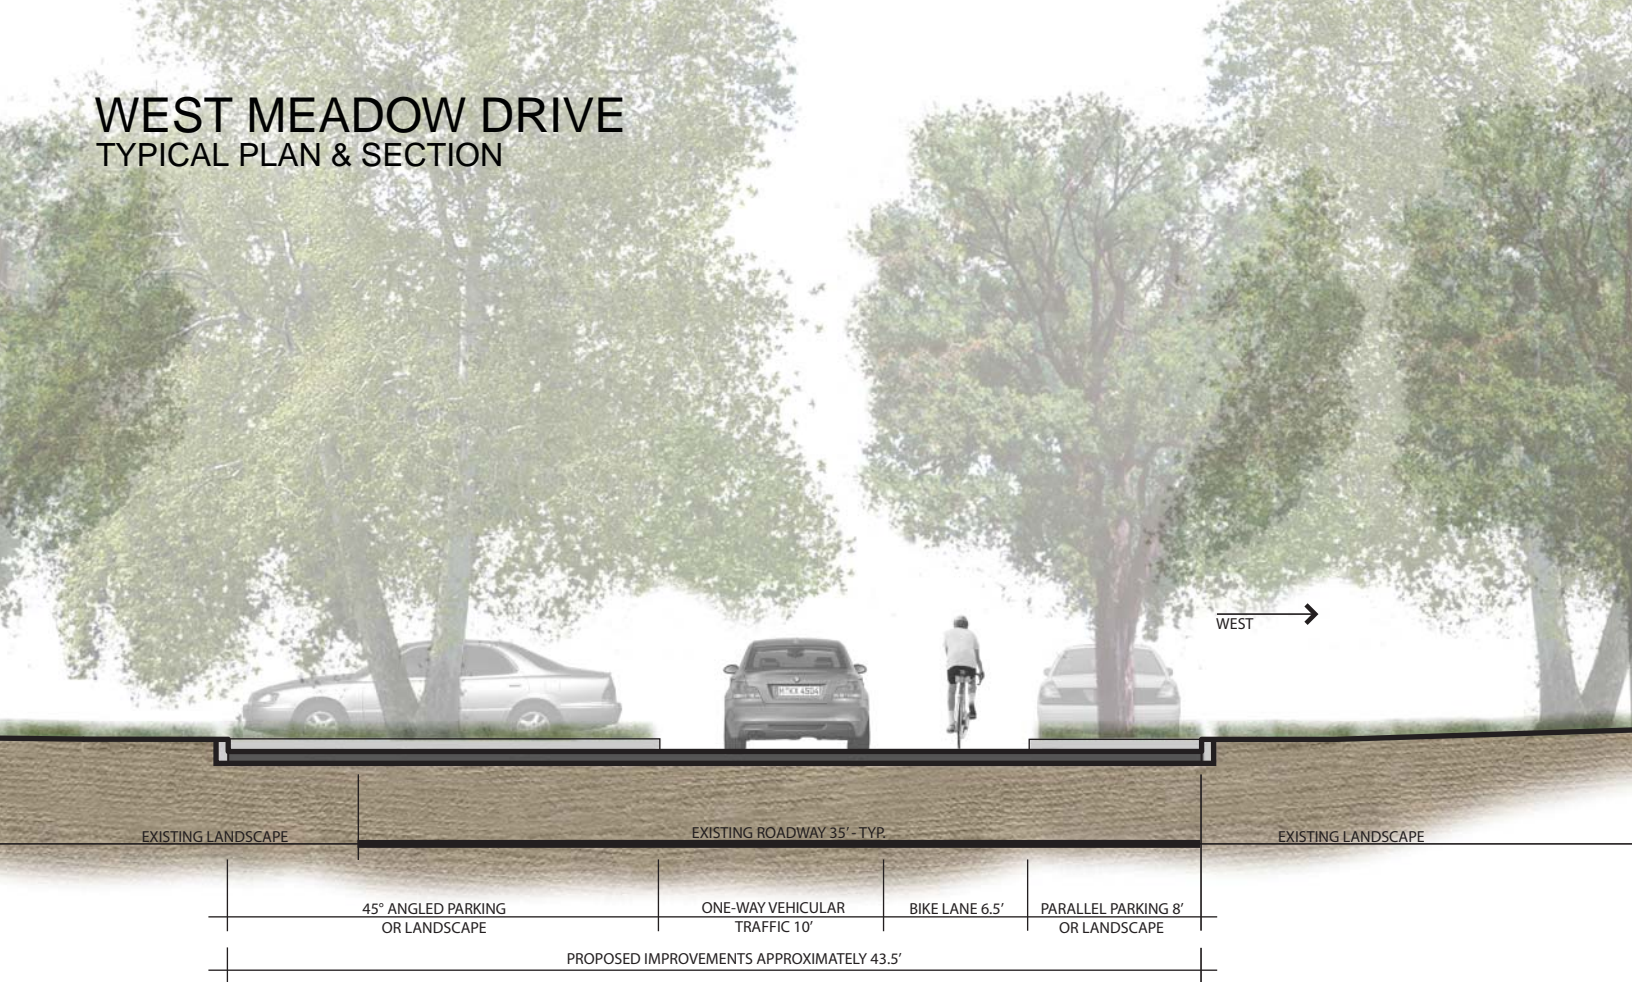
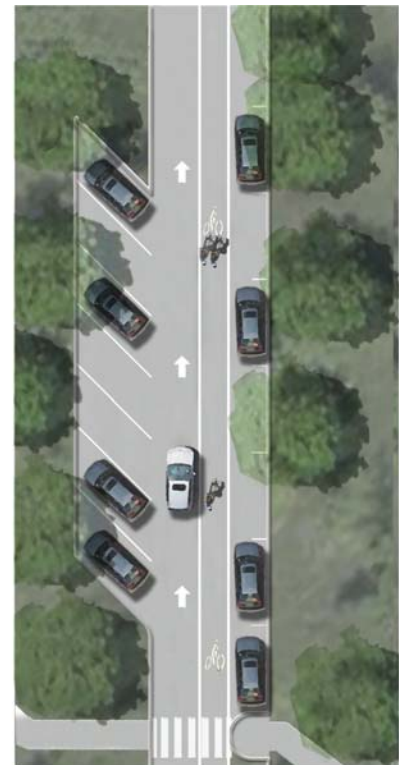
# WEST MEADOW DRIVE

- One-way auto & bike traffic
- Parallel parking on the outer edge
- 45° pull-in parking on inner edge in select areas
- 6.5' bike lane
- No attached walks
- Neck downs at pedestrian crossing on parallel parking side
- Striping at pedestrian crossings
- Curb & gutter
