# CIRCULATION AND USE PLAN FOR DENVER'S CITY PARK

RESTORATION IMPROVEMENTS  
ASSESSMENT AND RECOMMENDATIONS

September 2010

PREPARED FOR DENVER PARKS AND RECREATION

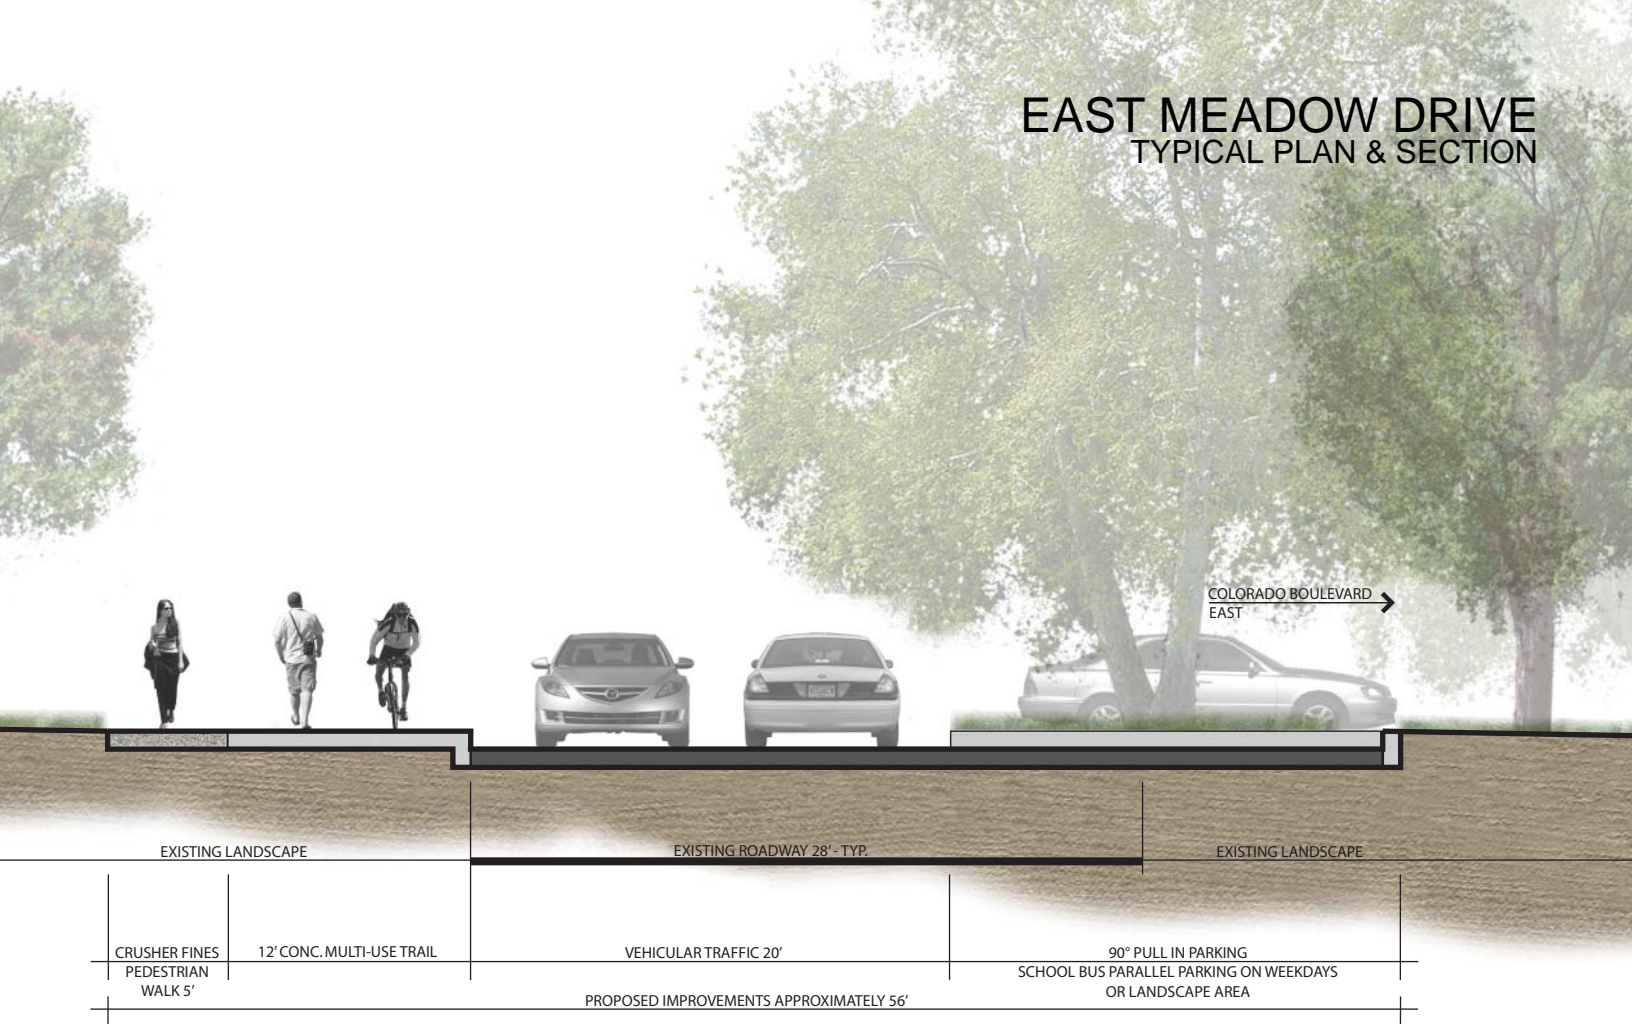
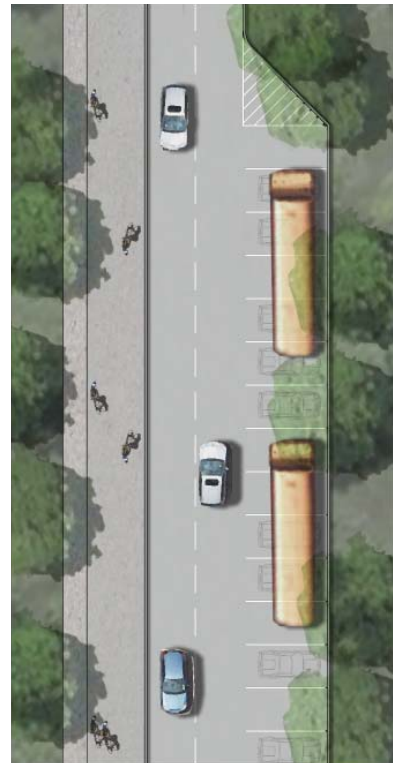
# EAST MEADOW DRIVE TYPICAL PLAN & SECTION

- Two-way auto traffic
- 90° pull-in parking on inner edge (also used as Bus parking)
- Turn around at the end of the road sized to accommodate bus traffic
- Attached 12' concrete Multi-use trail along the west side with a 5' crusher fines trail
- Striping at pedestrian crossings
- Curb & gutter
- On-street to off street transition will be required for bicycles

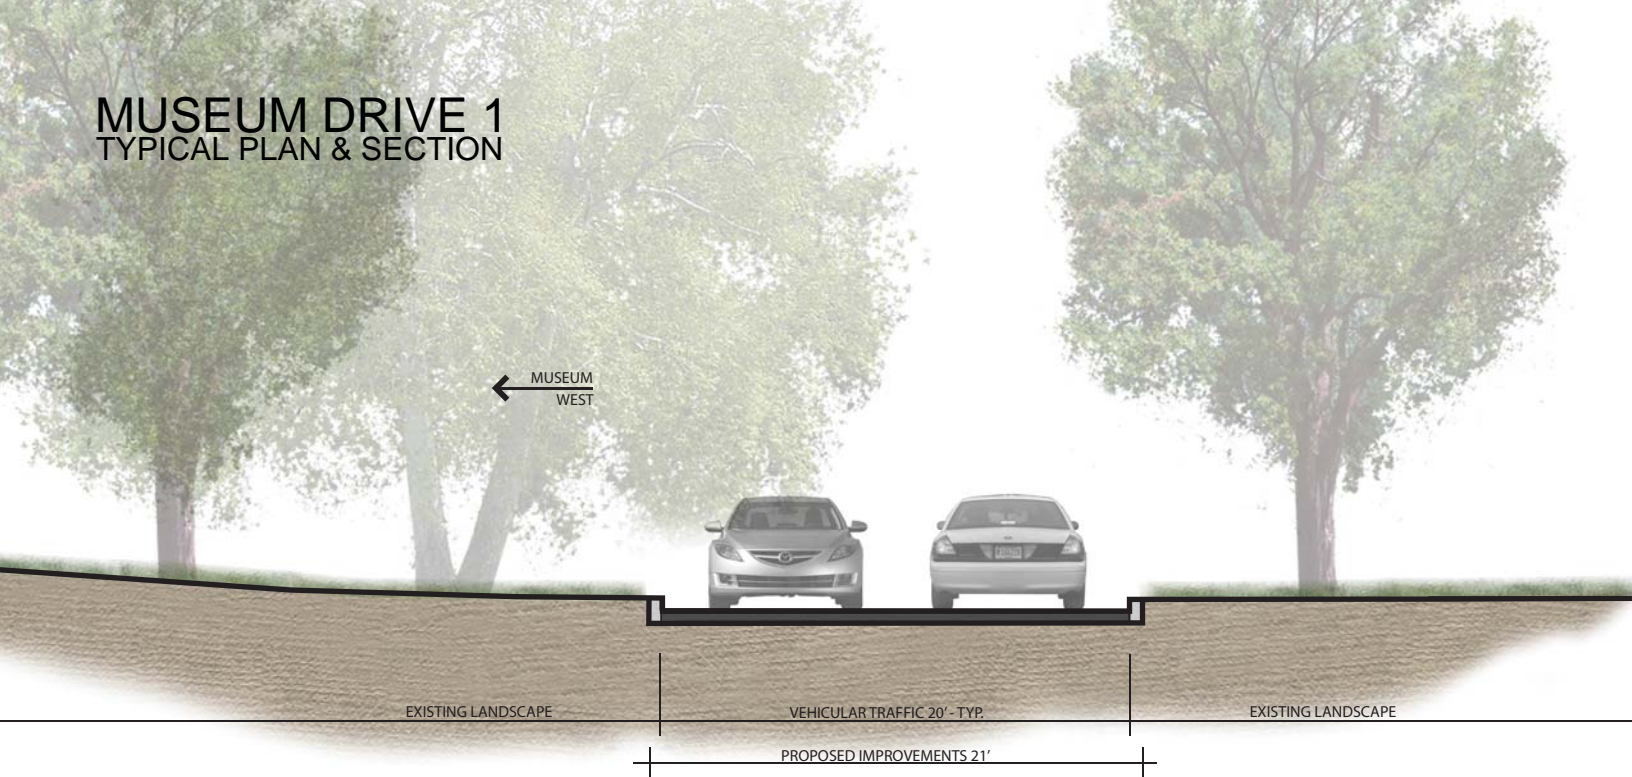
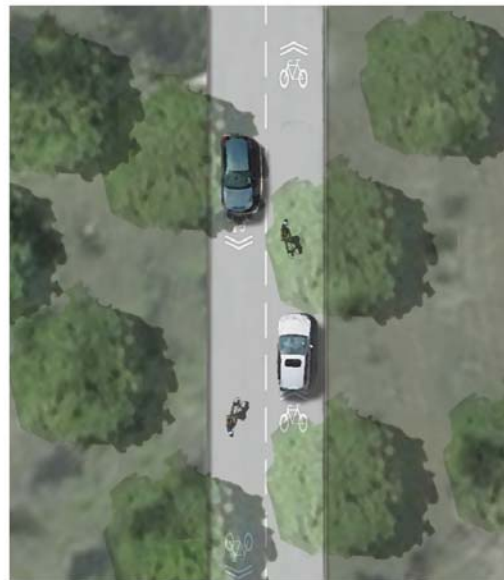
# MUSEUM DRIVE 1

- Two-way auto & bike traffic (shared lanes)
- No parking
- No attached walks
- Striping at pedestrian crossings
- Curb & gutter

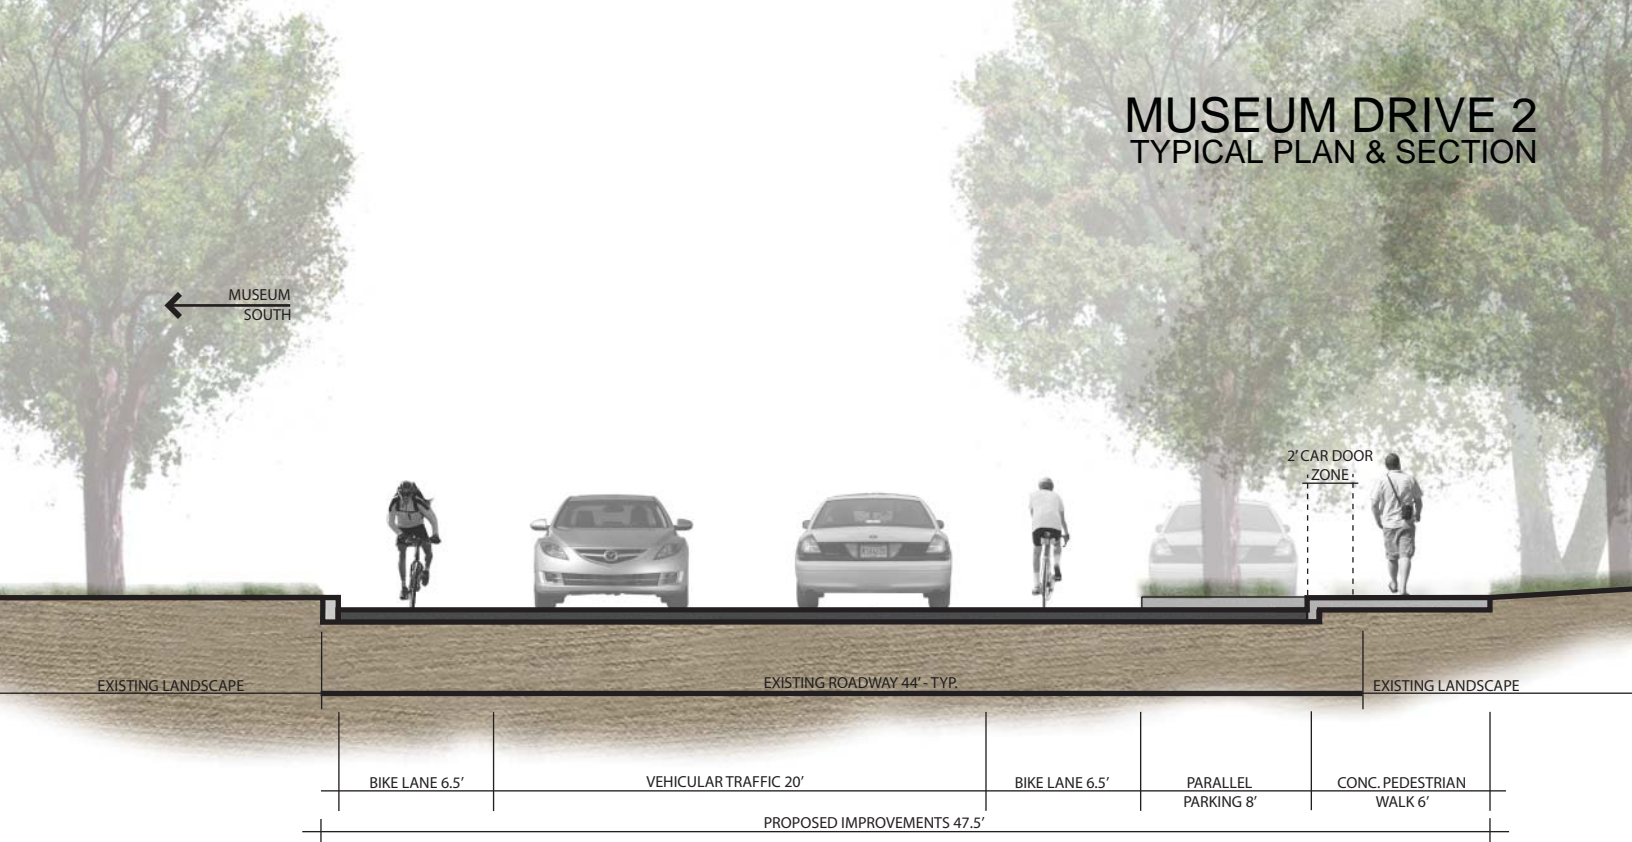
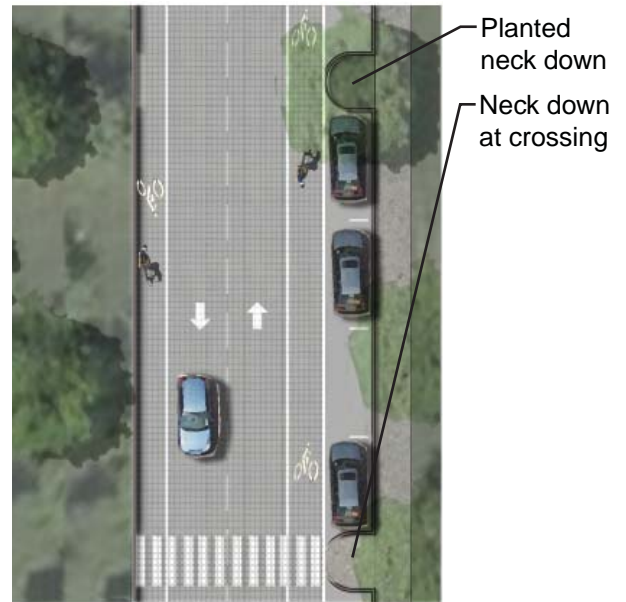
# MUSEUM DRIVE 2 TYPICAL PLAN & SECTION

- Two-way auto & bike traffic (dedicated lanes)
- Parallel parking on the north side
- No parking on the south side
- 6.5' bike lanes
- 8' attached concrete walk on the north side (to allow for car doors to open & pedestrian traffic to safely pass)
- Neck downs at pedestrian crossing on the north side only (at parallel parking)
- Planted neck downs on the north side only (at parallel parking)
- Striping at pedestrian crossings
- Curb & gutter

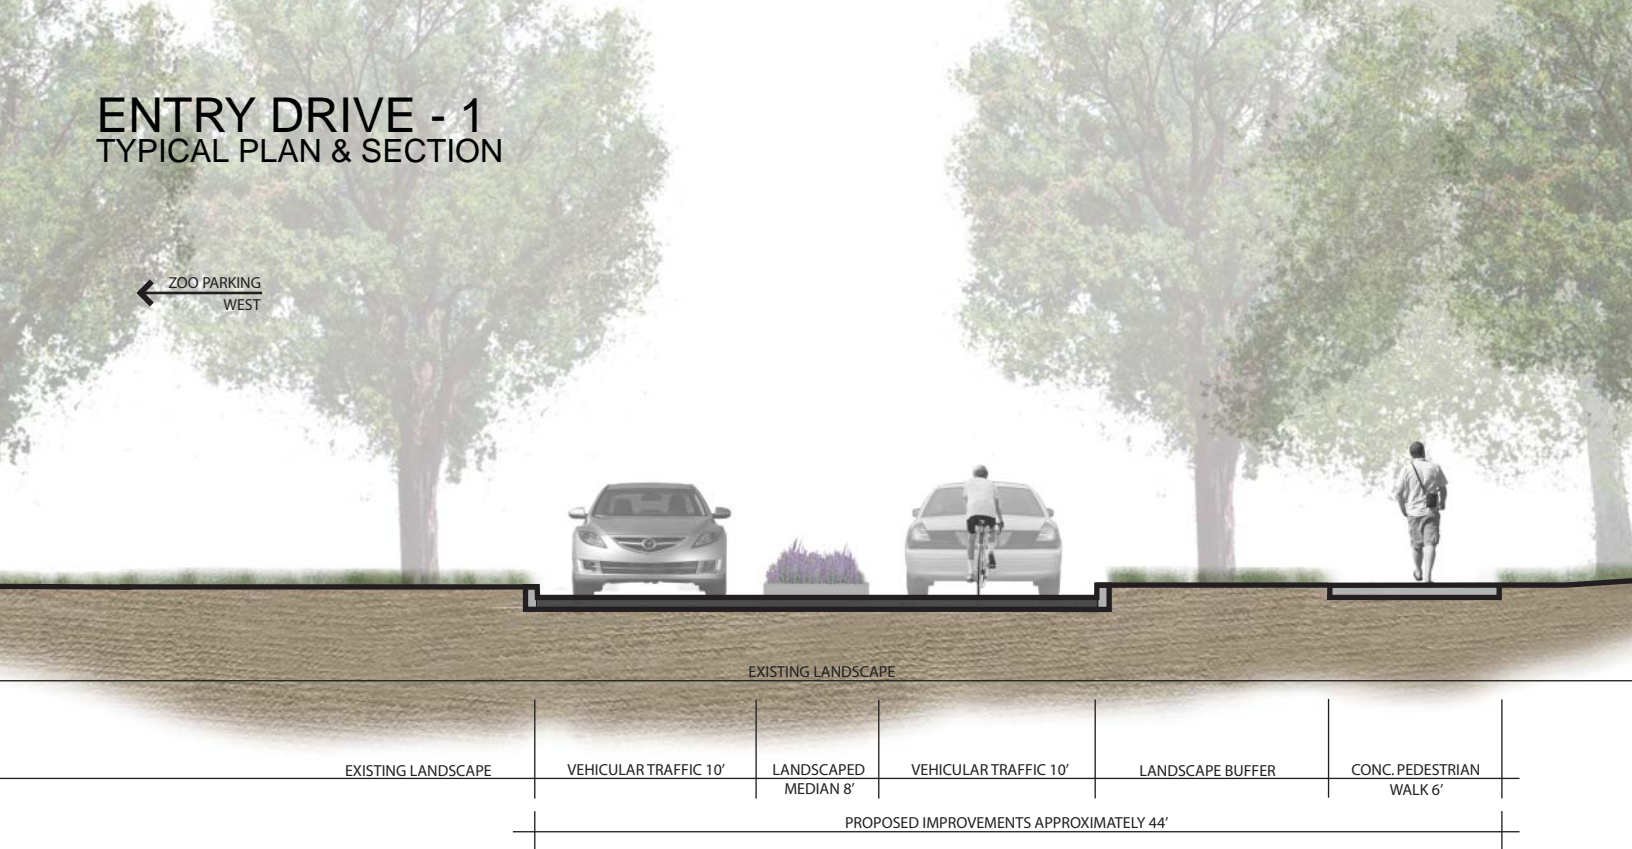
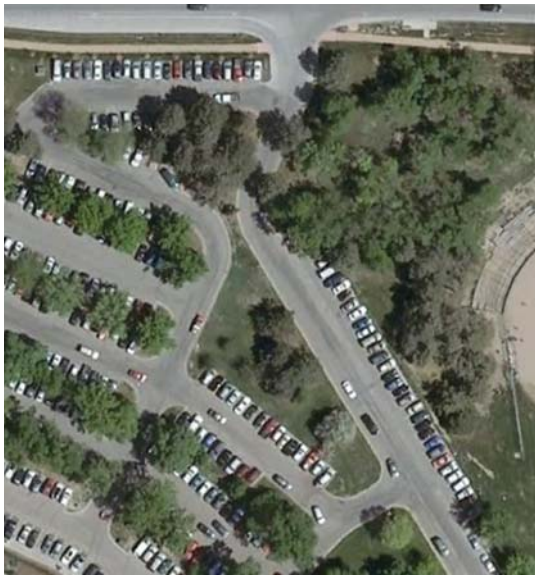
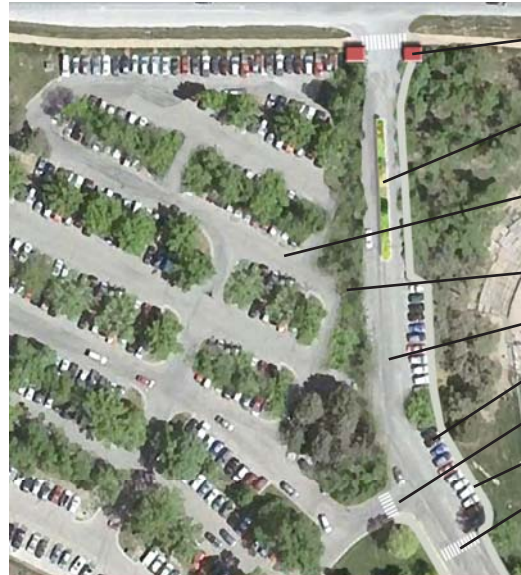
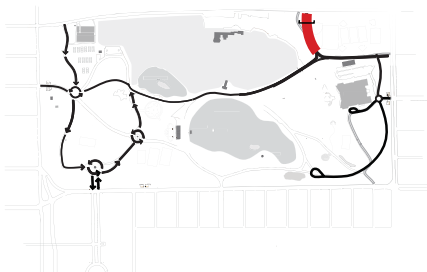
ZOO PARKING  
WEST

- Reconfigured entry allows for more direct park road access
- Reconfigured entry allows for additional Zoo parking

- Two-way auto & bike traffic (shared lanes)
- No parking on the west side
- 6' detached concrete walk on the east side
- 90° parking on the east side
- Striping at pedestrian crossings
- Curb & gutter

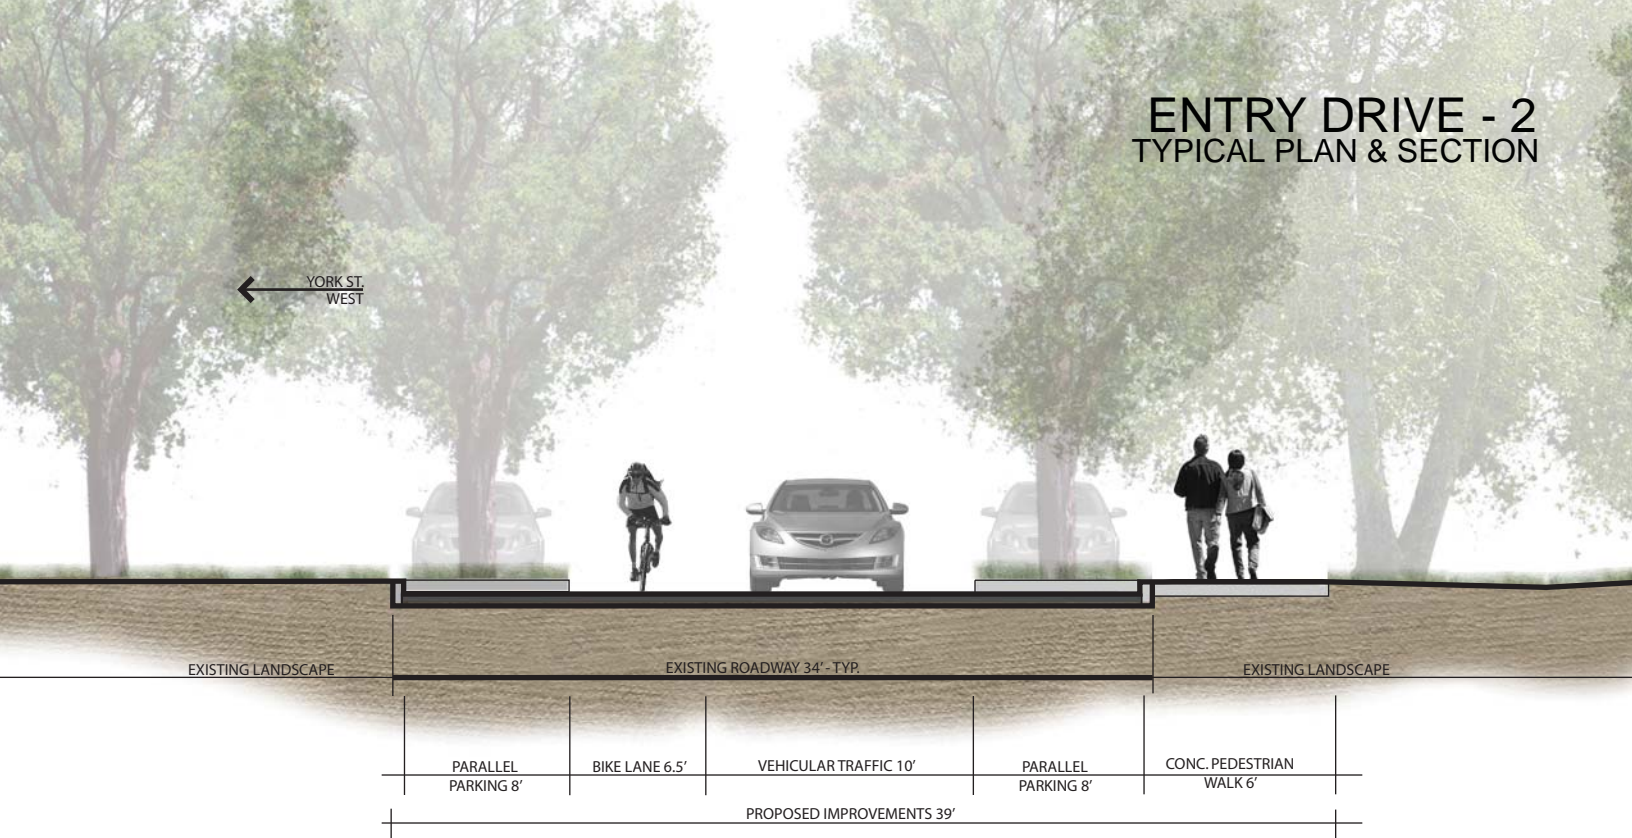
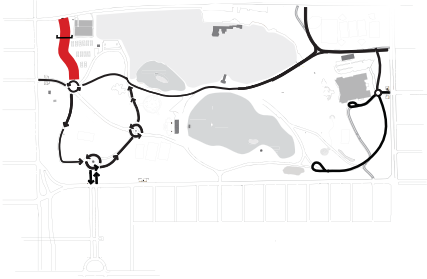
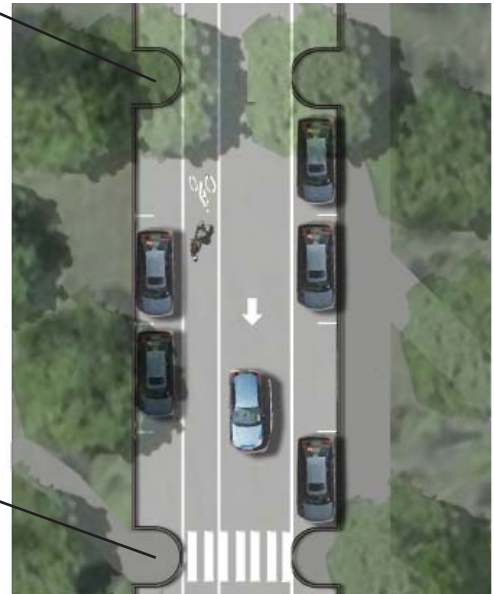
# ENTRY DRIVE - 2 TYPICAL PLAN & SECTION

Planted  
neck down

Neck down  
at crossing

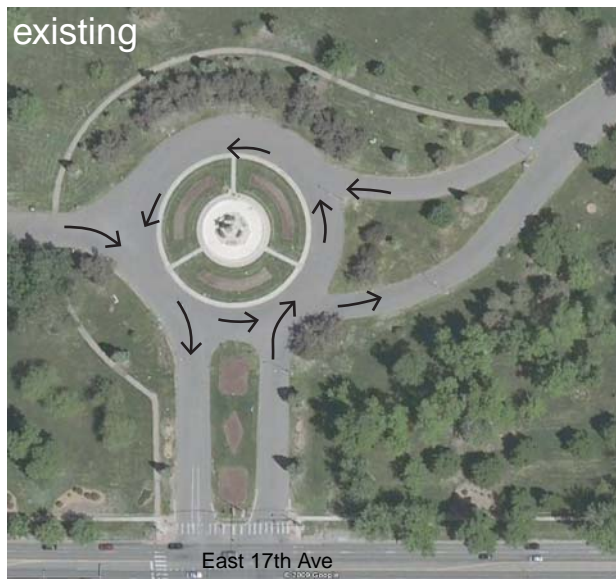
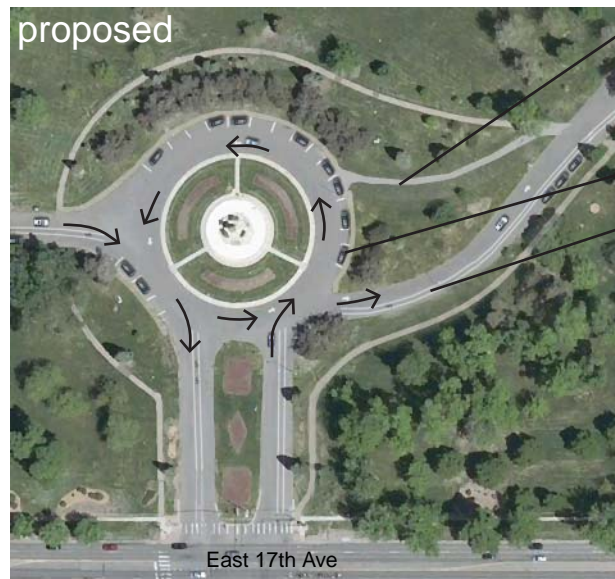
# ESPLANADEROUNABOUT

- Close existing road & convert it to a pedestrian trail
- Parallel parking
- Bike lanes

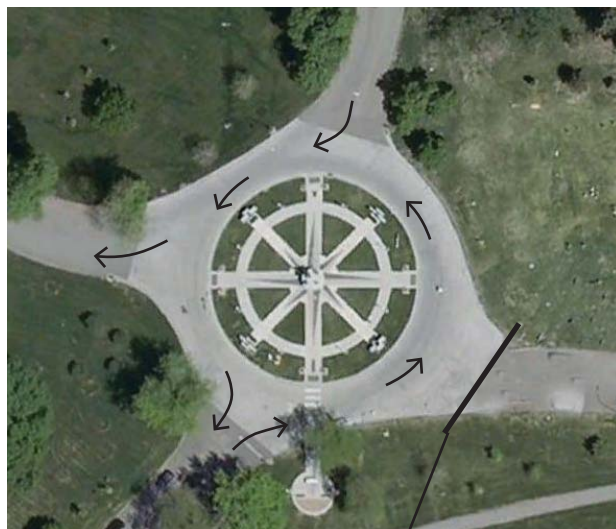
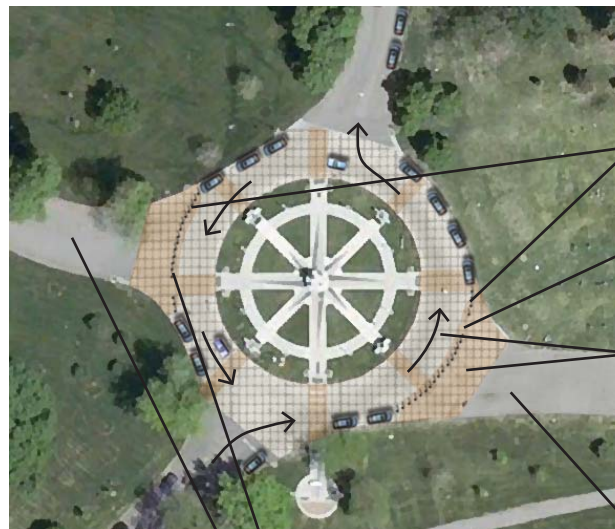
# MARTIN LUTHER KING JR. ROUNDABOUT

- Removable bollards spaced @ 5' o.c.
- Leave space for maintenance vehicle access
- Score, sandblast & color existing pavement or replace with pavers
- Road closed to auto traffic
- Leave space for maintenance vehicle access
- Road closed to auto traffic

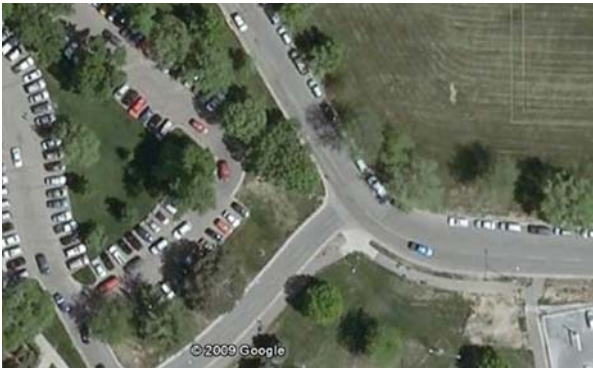
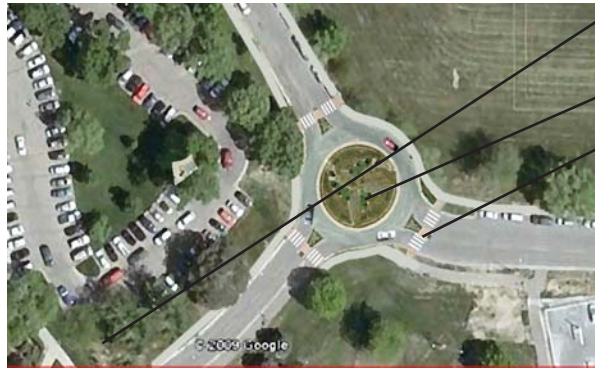
## PARK ENTRANCE ROUNDABOUT

- Close zoo parking lot access
- Add roundabout
- Crosswalks with pedestrian refuge

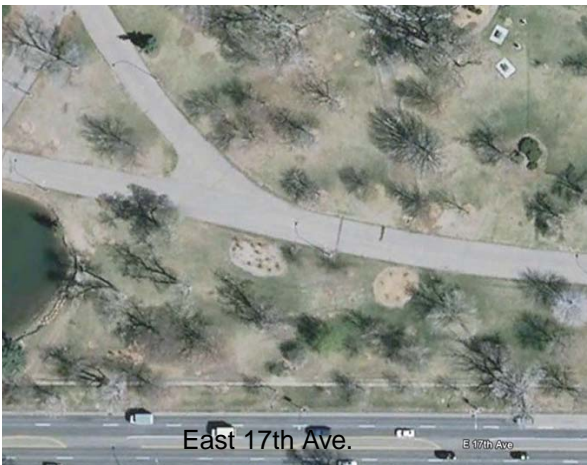
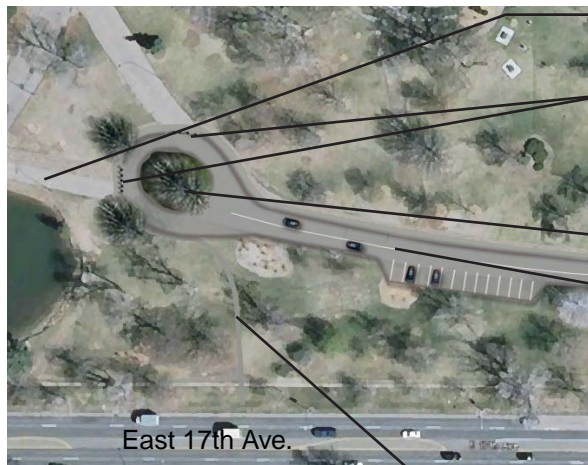
## EAST MEADOW TURNAROUND

- RE: Pedestrian Promenade 2
- Removable bollards with space to allow for maintenance vehicle access
- New turnaround
- RE: East Meadow Drive

- Turnaround must accommodate bus & emergency vehicles

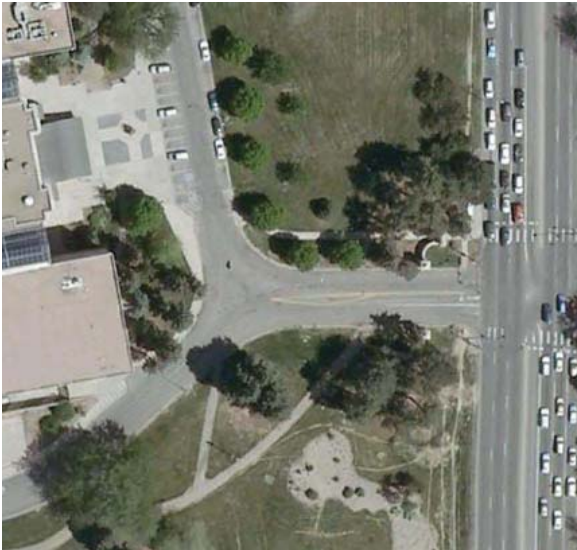
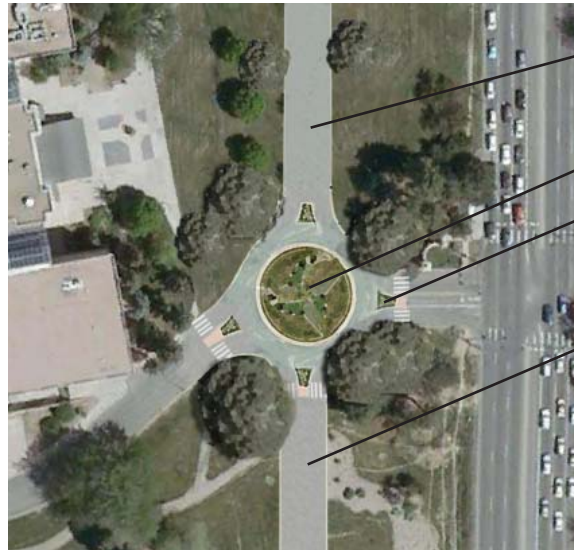
# MUSEUM ROUNDABOUT

- Realigned road
- Add roundabout
- Crosswalks with pedestrian refuge
- Realigned road

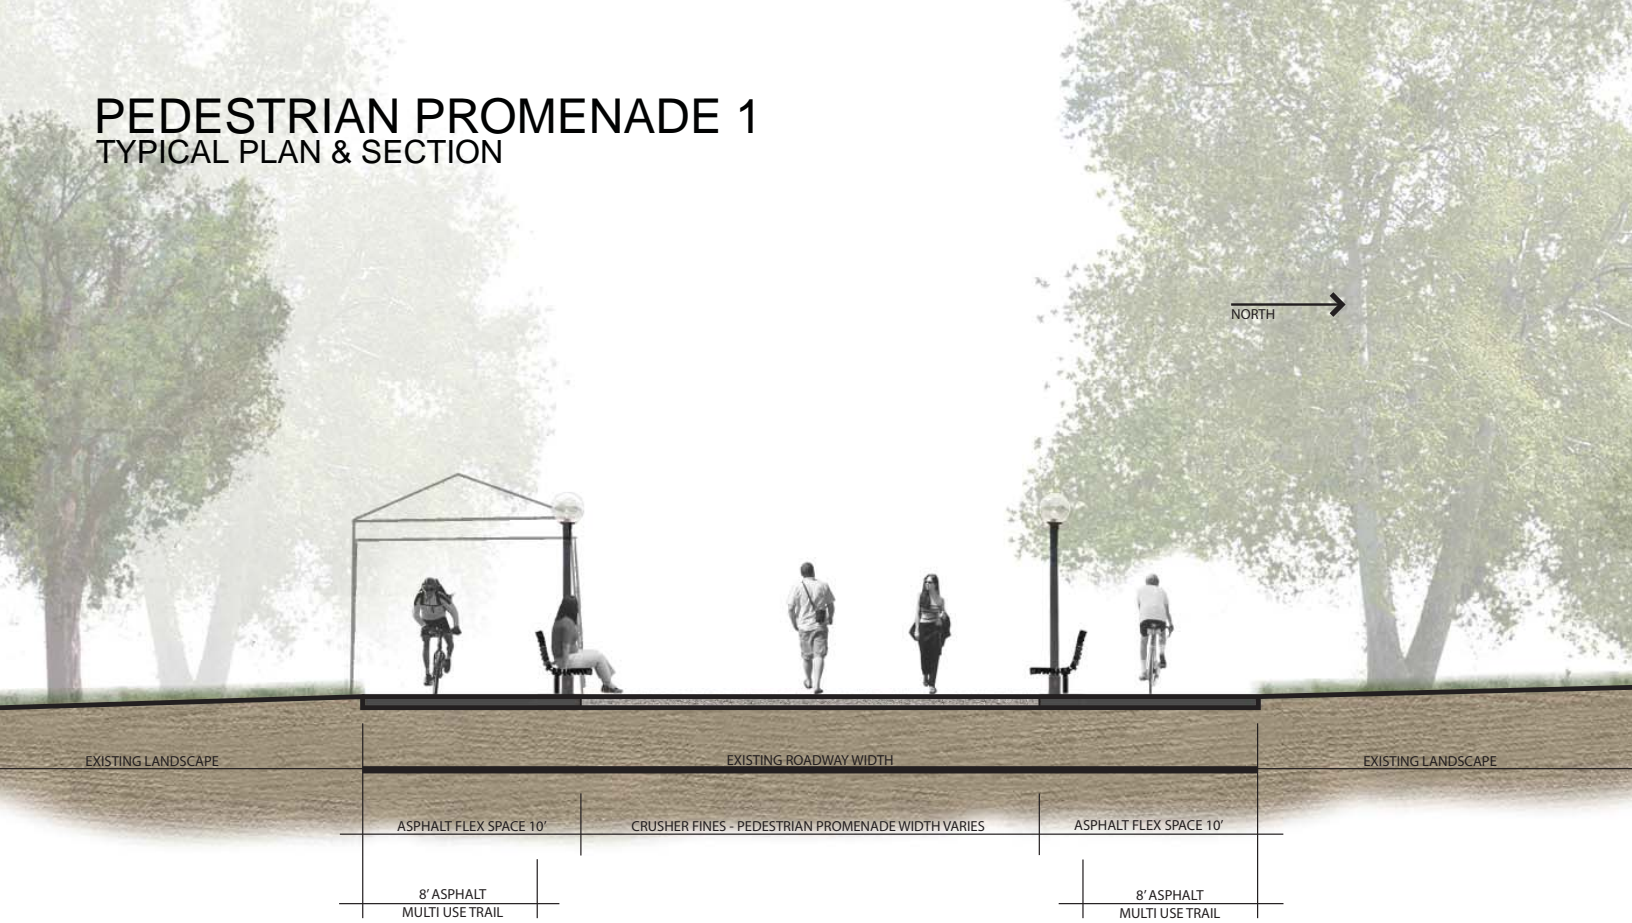
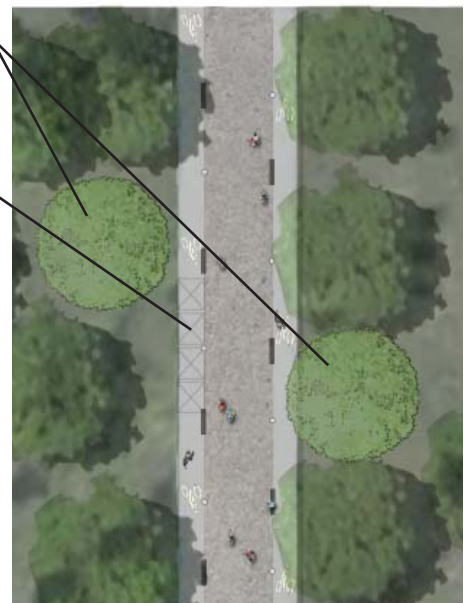
# PEDESTRIAN PROMENADE 1

New trees should maintain the original allee alignment

Flexible space for event tents or multi use path

- Crusher fines replaces asphalt in the center of the promenade - storm drainage must be maintained.
- One-way, multi-use trails on outer edges (doubles as flexible event space)
- Pedestrian lights, trash cans, & benches regularly spaced
- New trees must maintain original allee alignment

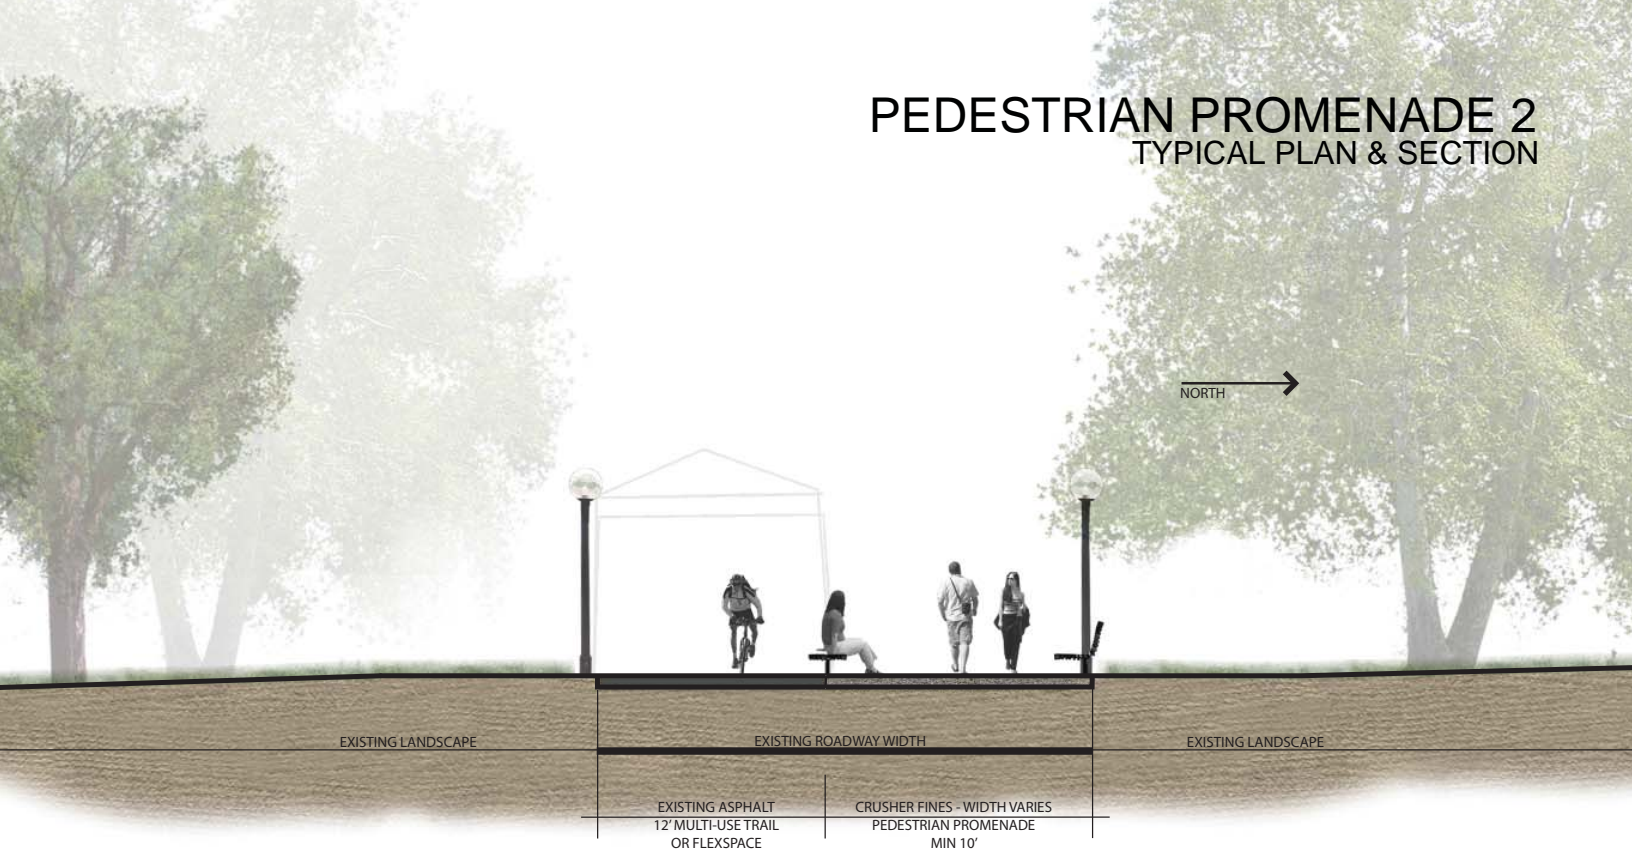
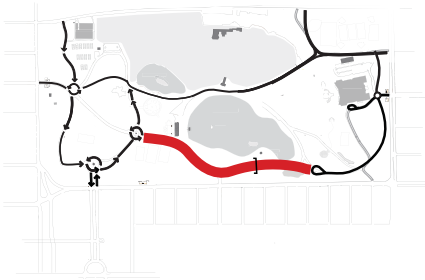
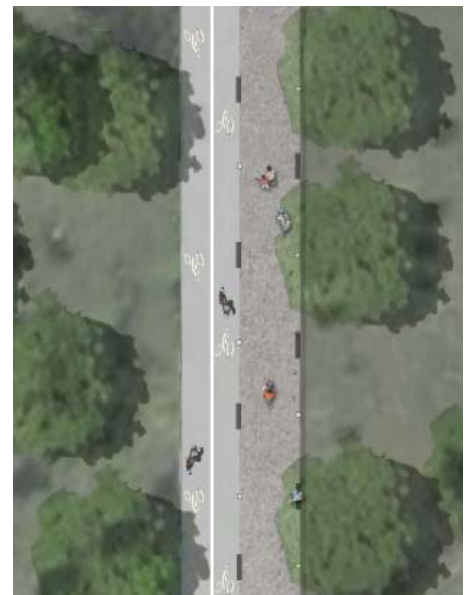
- Crusher fines replaces asphalt on the North side of the promenade
- Multi-use trail on South side (doubles as flexible event space)
- Pedestrian lights, trash cans, & benches regularly spaced
- New trees must maintain original allee alignment

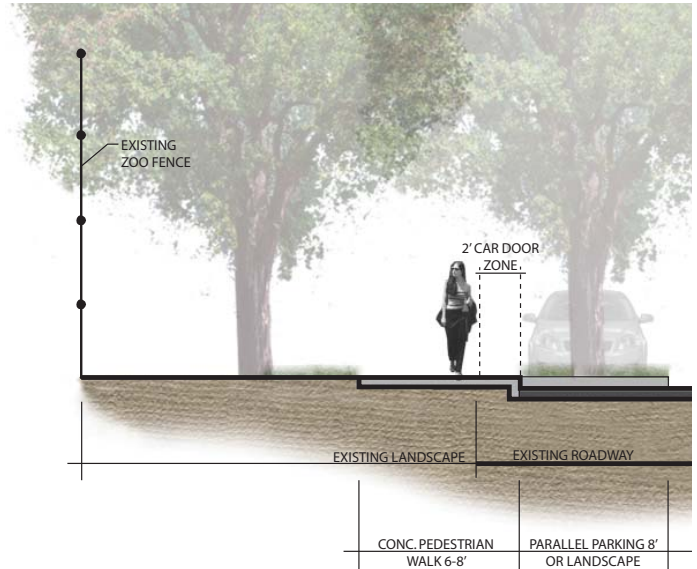
## ZOO LOOP

- Enhanced Zoo pedestrian access
- Enhanced Duck Lake pedestrian access
- Stroller accessible
- Attached sidewalks next to parallel parking must allow for car doors to open & pedestrian traffic to safely pass (min. 8' width).
- 6' width when there is no adjacent parallel parking
- Sidewalks are attached concrete walks when adjacent to road
- Creative integrated way-finding which directs to zoo (sandblasted, concrete bands, etc.)
- Trash cans where needed
- No lighting
- No benches
- Curb & Gutter.

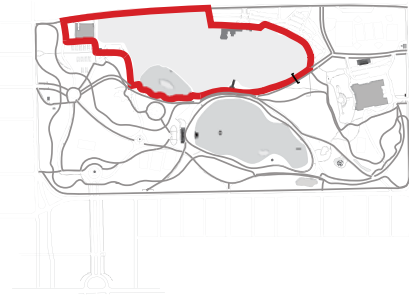
## PARK PERIMETER

- Path along the outer edge of the park
- 8' asphalt or concrete path with a crusher fines edge 2' for joggers

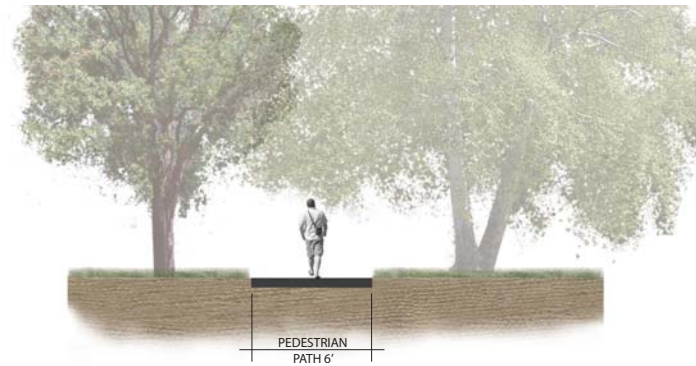
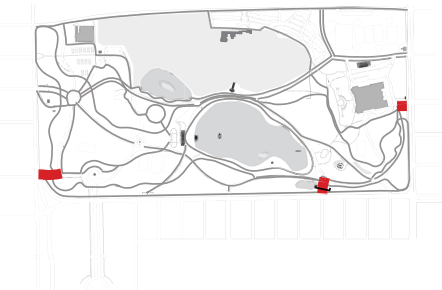
## NEIGHBORHOOD CONNECTIONS

- connects the "Park Perimeter" to the interior circulation
- 6' Asphalt path
- wayfinding
- direct connections

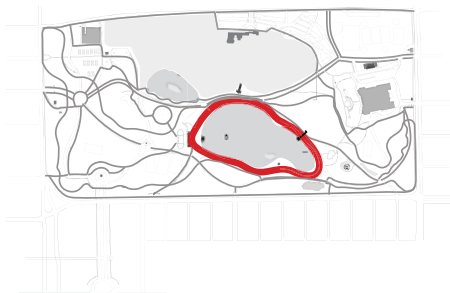
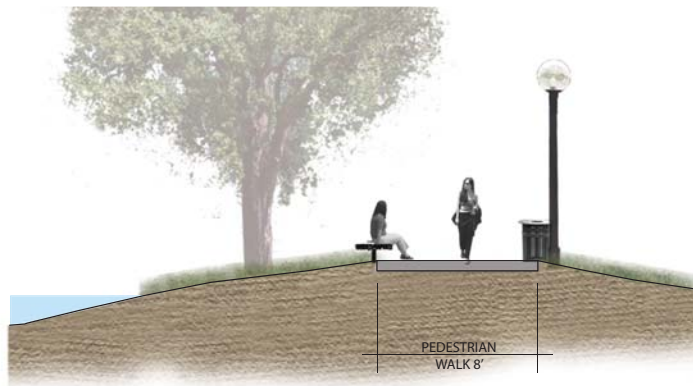
## LAKE LOOP [EXISTING]

- Add benches (two every 250') and trash cans (one every 1000') to south & north edges

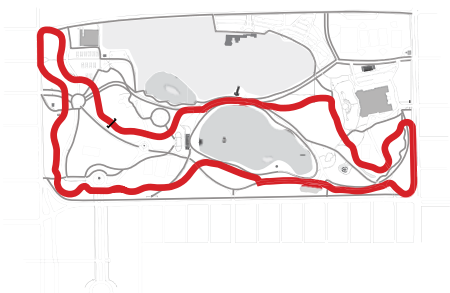
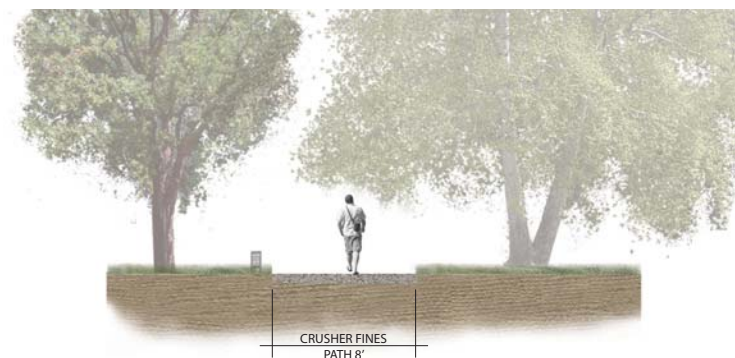
## 5280 TRAIL [EXISTING]

- Mile markers
